MEMORANDUM

SUBJECT: Grants Pass WTP – Inspection of the Clearwell (Inspection Date 5/24/2011)

On May 24, 2011, MWH conducted a follow-up inspection of the clearwell concrete roof and beams in the original 1930's constructed part of the building. A photo log of this visit is attached as Appendix A. The follow-up was conducted to determine a more-defined extent of the concrete deterioration that was first discovered during the March 2, 2011 inspection. As a reference, the March 2, 2011 report and photo log are attached as Appendix B. It should be noted that the March 2, 2011 inspection was focused on the area of the clearwell that was leaking in groundwater, but some other areas of concern were observed then as well. The leak area and general recommendations from the March 2, 2011 inspection are summarized below:

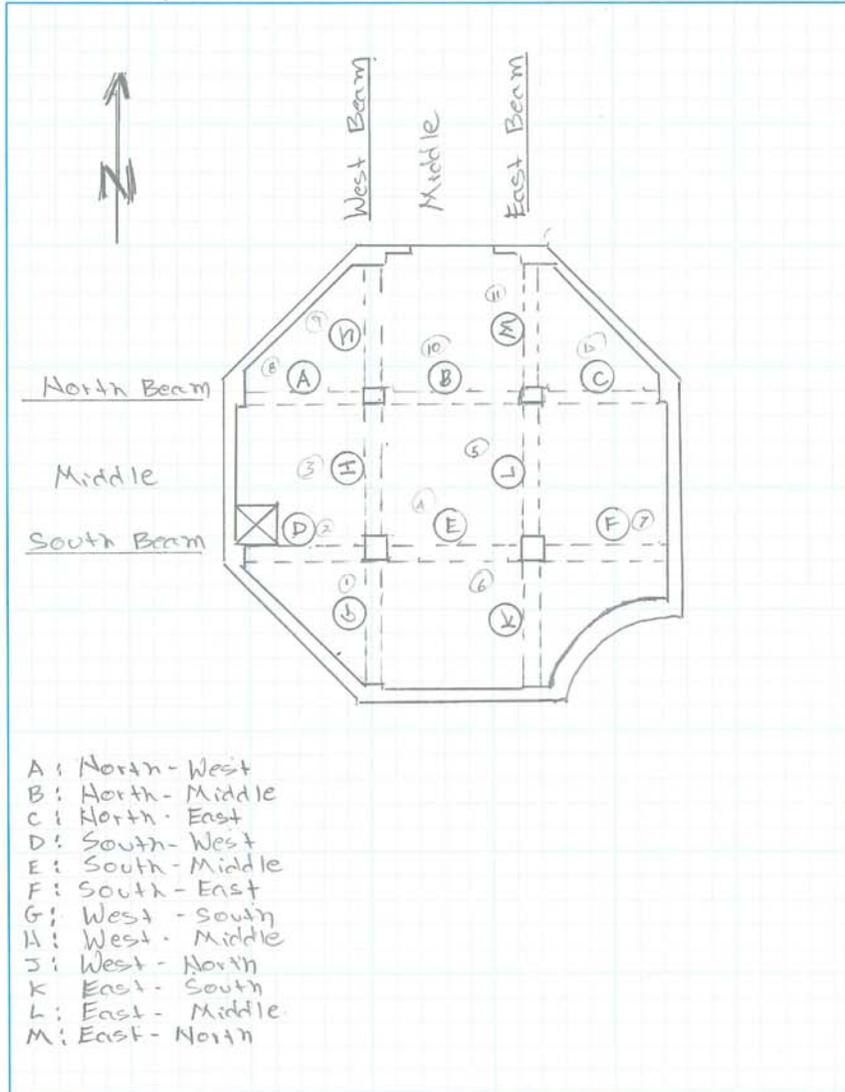
Figure 1

There are four interior concrete columns in the clearwell that divide the roof/beams into nine different panels. Running in the North/South direction, there are north, middle and south beams. Running in the East/West direction, there are east, middle and west beams. These beams and the exterior walls of the clearwell define the 9 different panels. Reference the attached sketch presented as **Figure 1**. The summary below makes use of the labeling defined above and shown in **Figure 1**.
