Structural/Seismic Evaluation, Grants Pass Water Treatment Plant, Grants Pass, Oregon

Final June 28, 2012

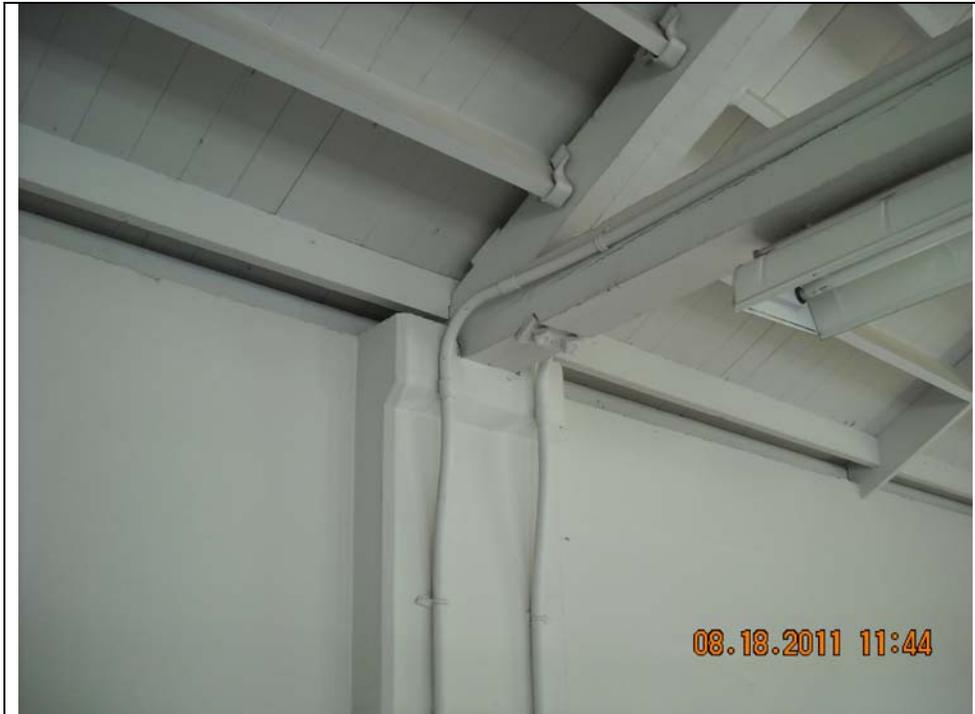
5. The gap between the straight wood sheathing and the top chord of the wood truss at the filter building does not allow lateral wall out of plane shear transfer from the truss top chord into the straight sheathed wood diaphragm. The straight sheathed wood diaphragm is also inadequate to transfer the high seismic load demands. The result of these multiple vulnerabilities is that the as-built roof structure is a collapse hazard in a strong ground motion earthquake.

Figure 1 – Lack of wall to roof anchorage at Trusses. Gap between straight sheathing and truss top chord

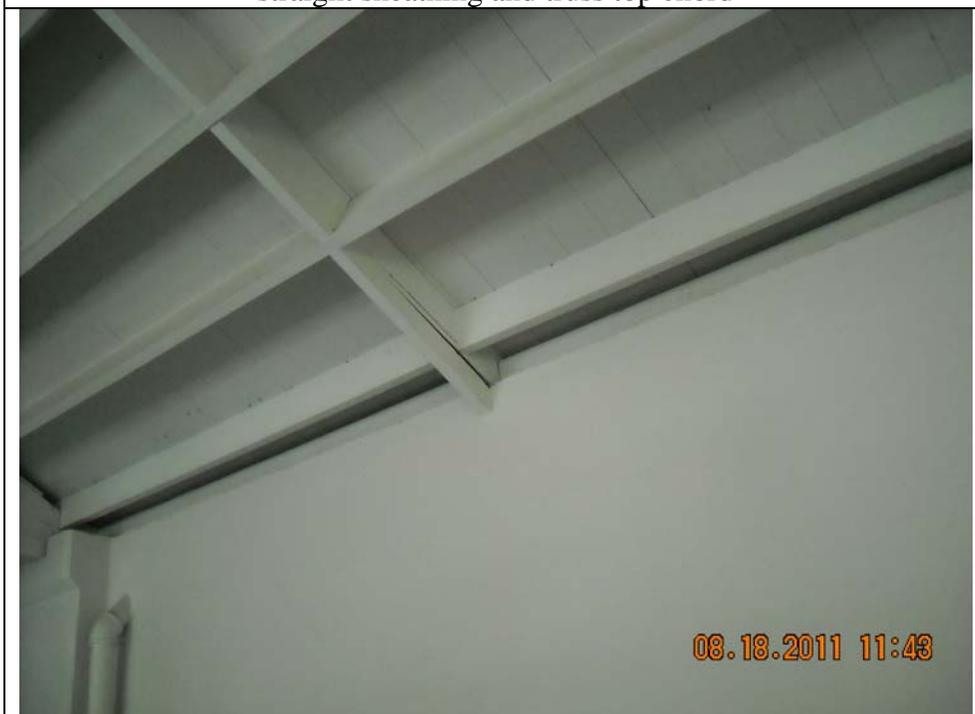
Figure 2 – Split Blocking needing replacement and anchorage to wall.

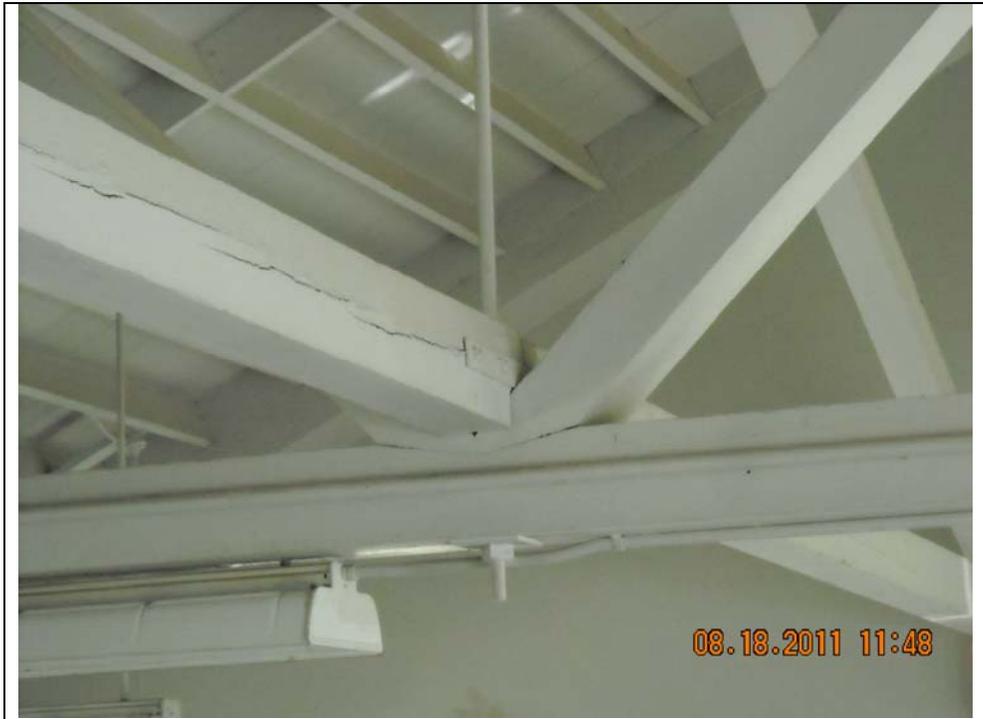
Figure 3 – Split bottom chord bracing at bolt line.

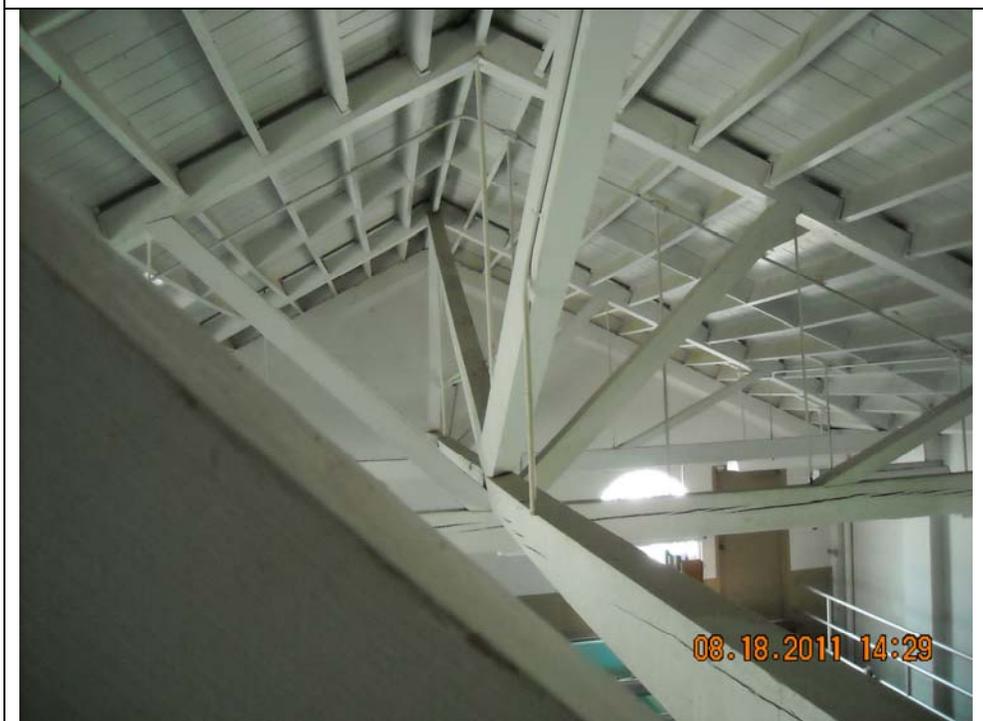
Figure 4 – Split bottom chord of truss

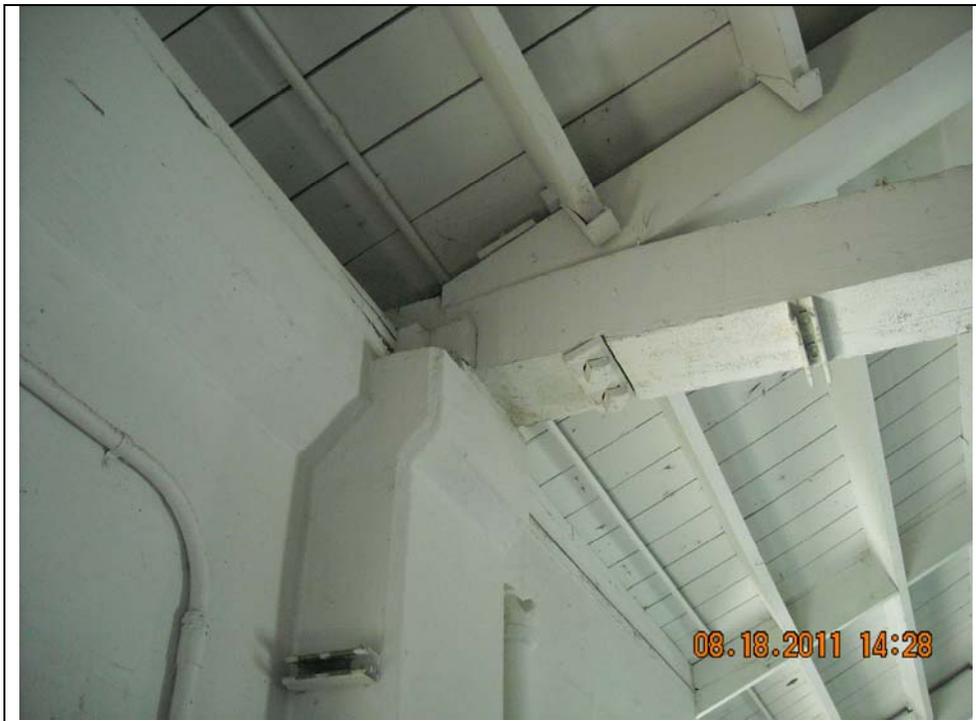
Figure 5 – Lack of wall to roof anchorage at Trusses. Gap between straight sheathing and truss top chord

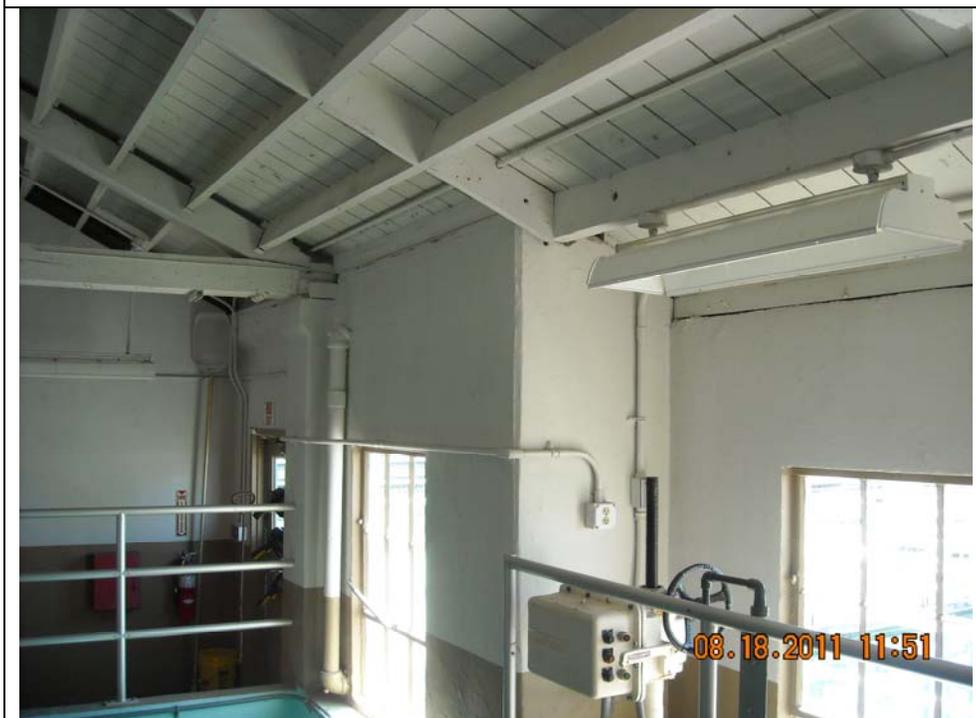
Figure 6 – Straight wood sheathing, re-entrant corner, lack of collector connection.

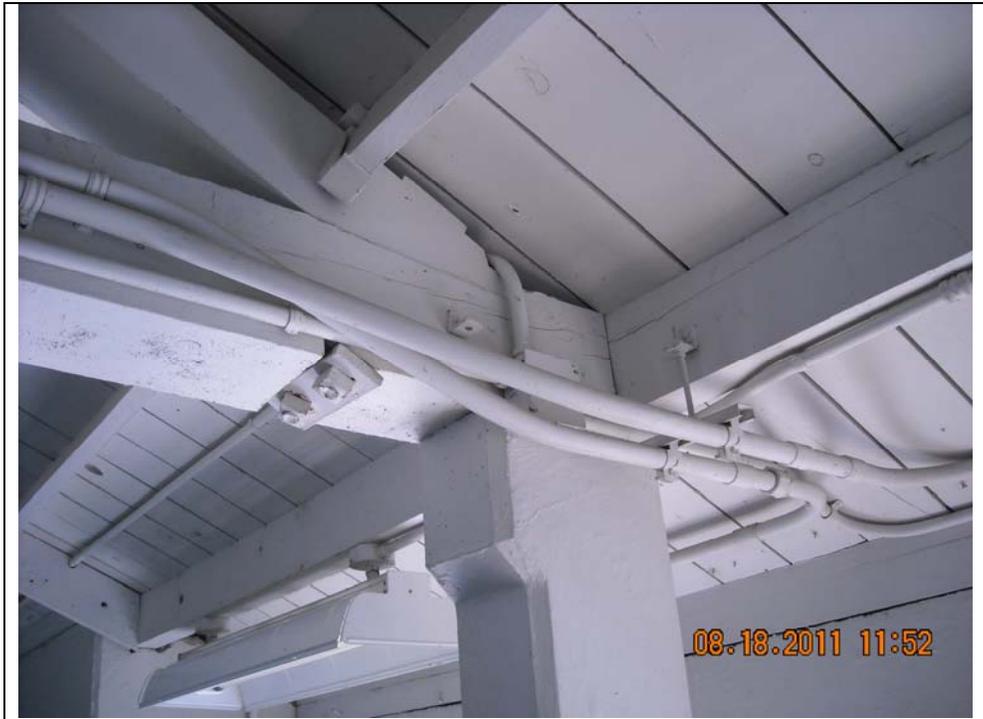
Figure 7 – Lack of anchorage at top of column and lack of chord/collector connection.

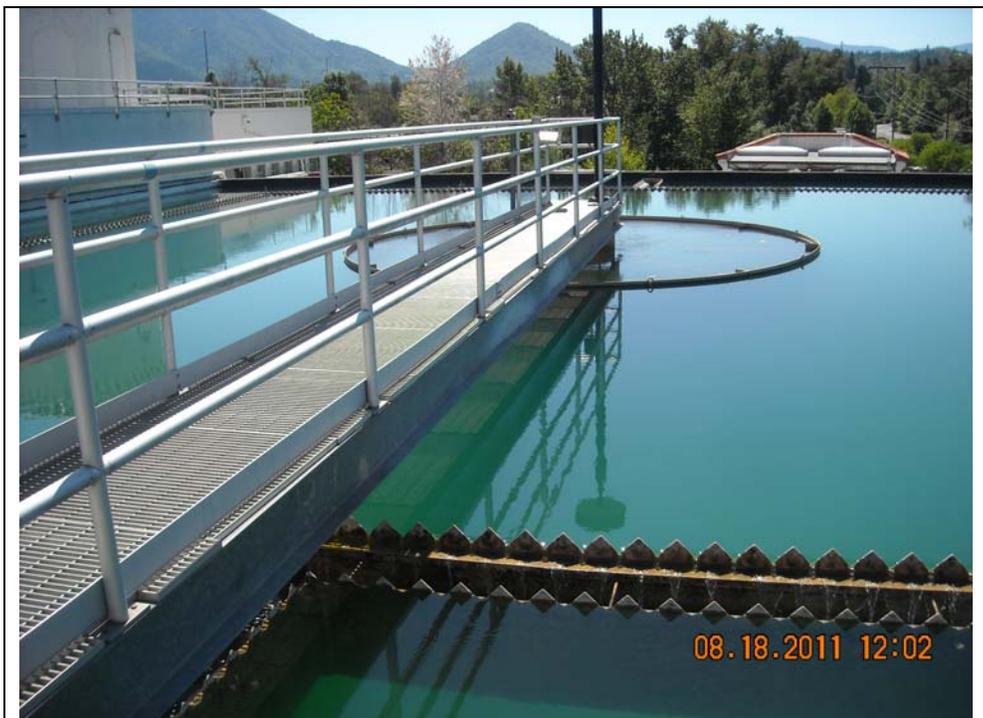
1. The 80-foot square sedimentation basin with the single platform walkway out to the center of the sedimentation reaction well does not offer adequate seismic resistance to the hydrodynamic loads that can damage and collapse these elements into the basin during strong ground motion earthquakes. The 7-foot square foundation for the center column is too small to resist the large hydrodynamic forces. Strengthening of the platform by spanning clear across the basin with a new bridge/platform is a common method of seismically retrofitting this deficiency. Alternatively, process decisions can dictate the complete removal of the reaction well and platform to eliminate this seismic collapse risk.

Figure 8 – Sedimentation Basin Reaction Well lacking lateral support.

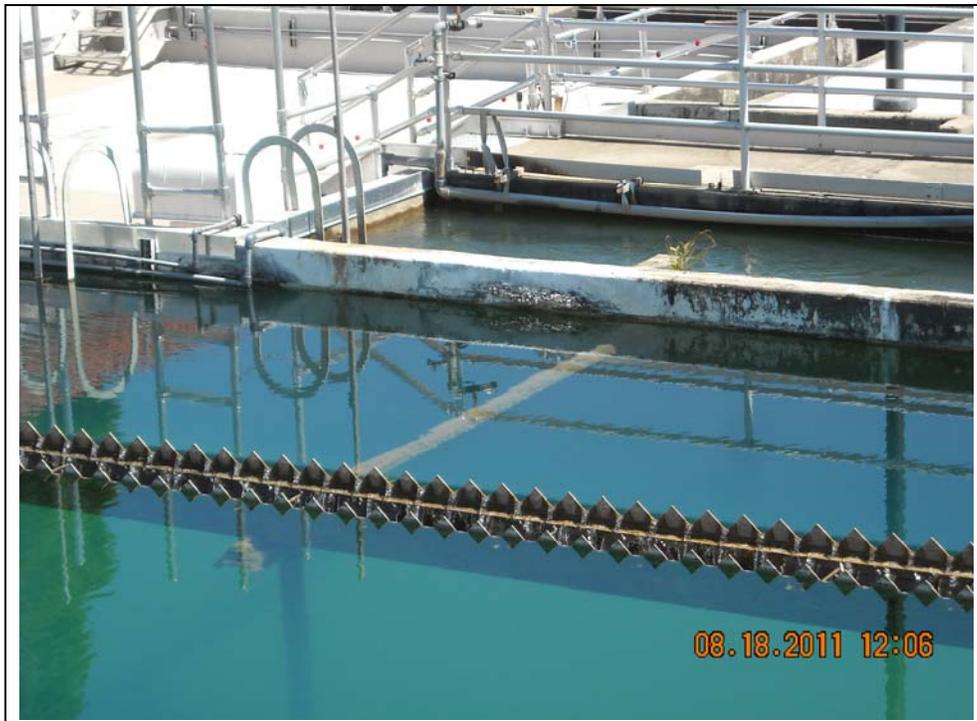
3. The sedimentation basin walls are thin and lightly reinforced and susceptible to significant hydrodynamic forces during a strong earthquake. Depending upon the acceleration of a strong ground motion earthquake, the results can likely be wall failure in bending. The acceleration of the earthquake can fail the walls in bending from the dynamic force of the water. The bending cracks, yielding of reinforcing and crushing of concrete at the base of the walls will result in permanent deformations of the walls and cause leaks through the cracks. Retrofitting the basin walls is possible and was outlined in the Grants Pass WTP Technical Memorandum titled "Structural and Seismic Upgrades for the Proposed Basin Improvements" (MWH - May 29, 2009). The retrofit described in the TM entailed the addition of 6-inch interior-face reinforced concrete walls to the existing walls.

Figure 9 – Thin Reinforced Concrete Sedimentation Basin Walls.

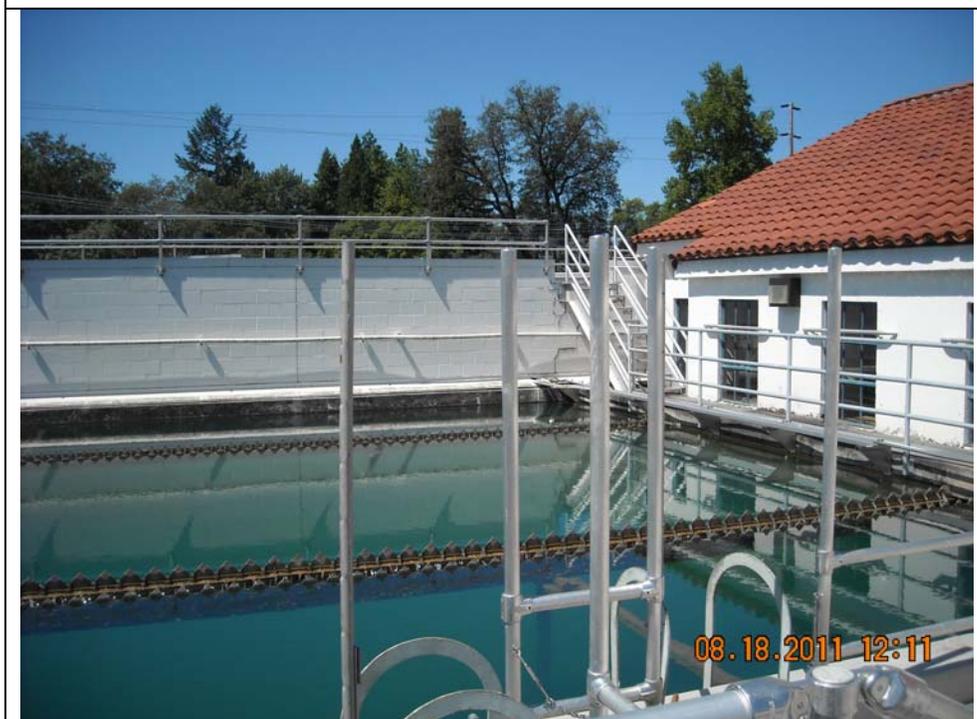
Figure 10 – Cracked CMU wall at corner interconnection from movement.

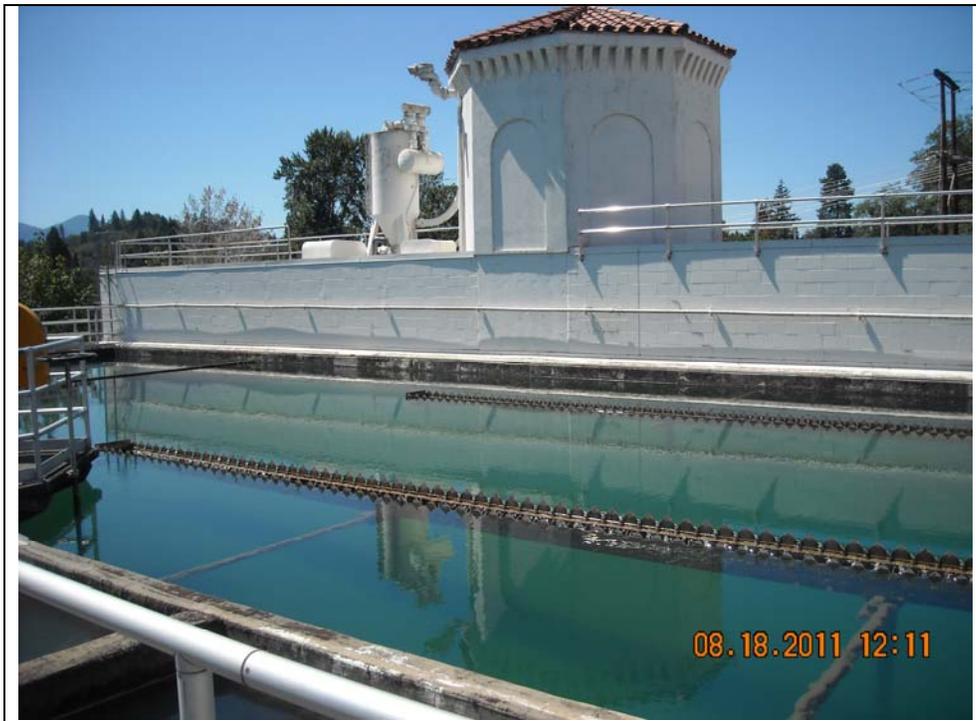
Figure 11 – Chemical Silo on roof susceptible to collapse.

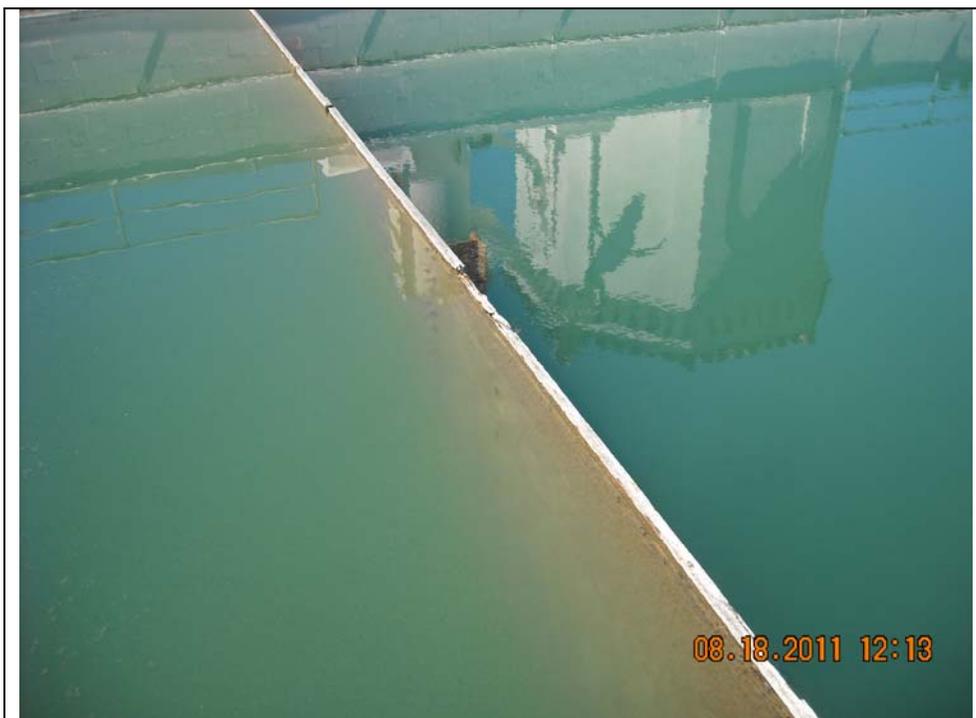
Figure 12 – Redwood Baffle Wall susceptible to hydrodynamic lateral load failure.

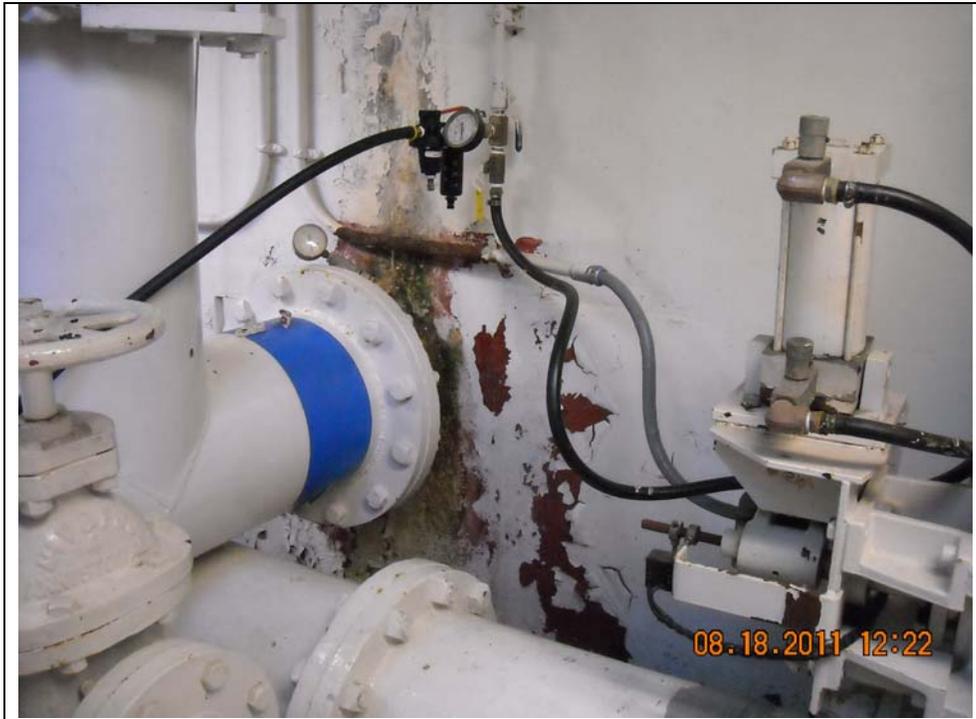
Figure 13 – Deteriorated/Corroded Reinforced concrete around pipe penetration susceptible to brittle failure.

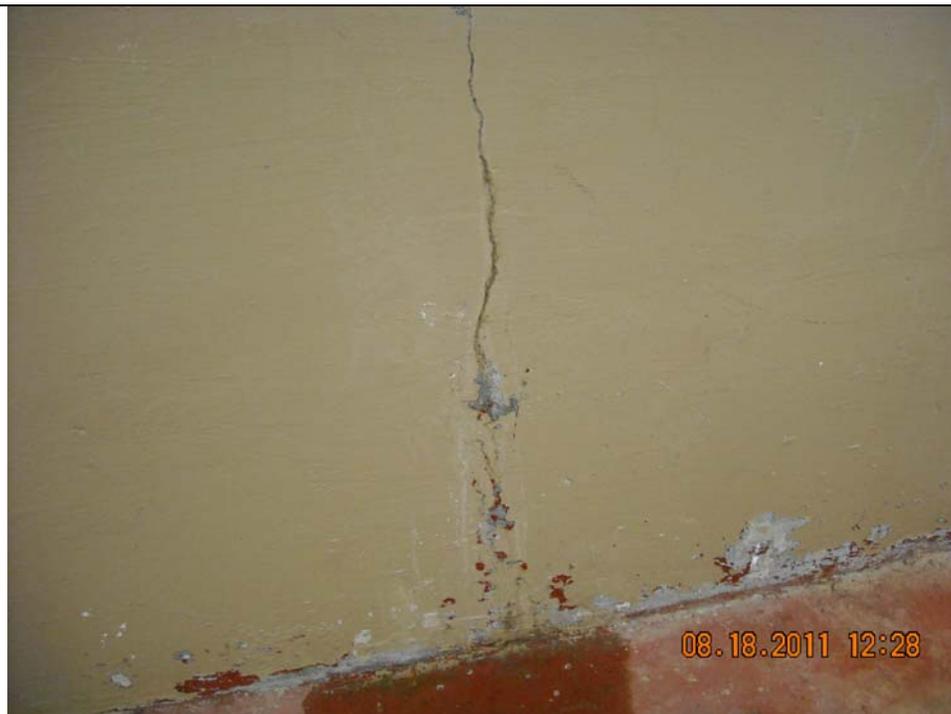
Figure 14 – Filter Gallery exterior wall cracking seepage

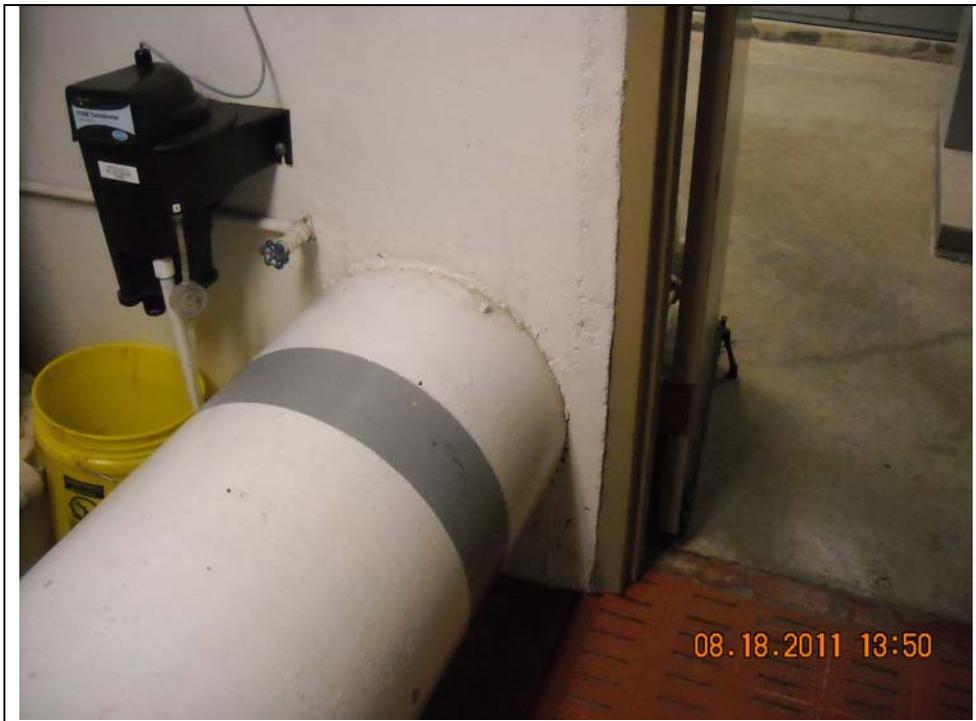
Figure 15 – Filter Gallery piping passing through wall that interrupts the jamb vertical steel

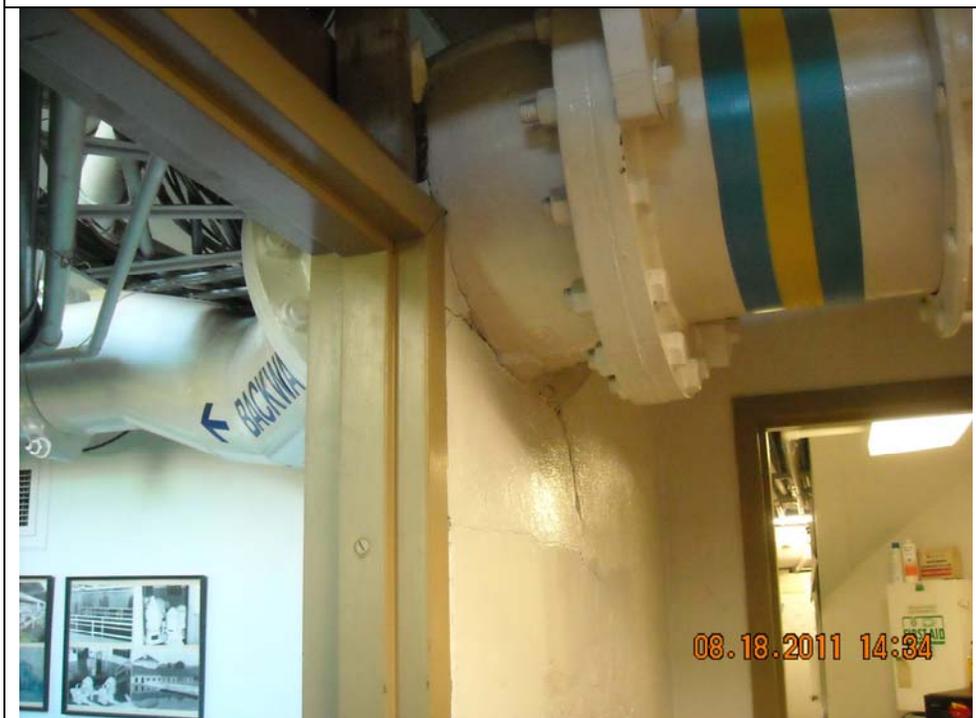
Figure 16 - Filter Gallery piping passing through wall that interrupts the jamb vertical steel and head horizontal steel

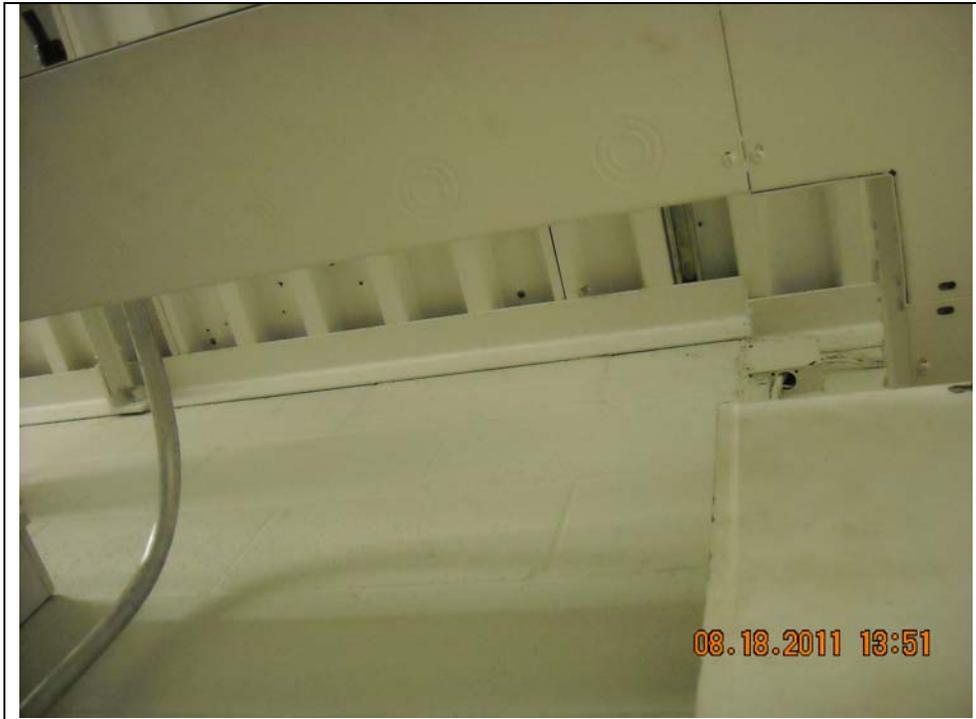
Figure 17 – Ledger angle missing anchor bolts

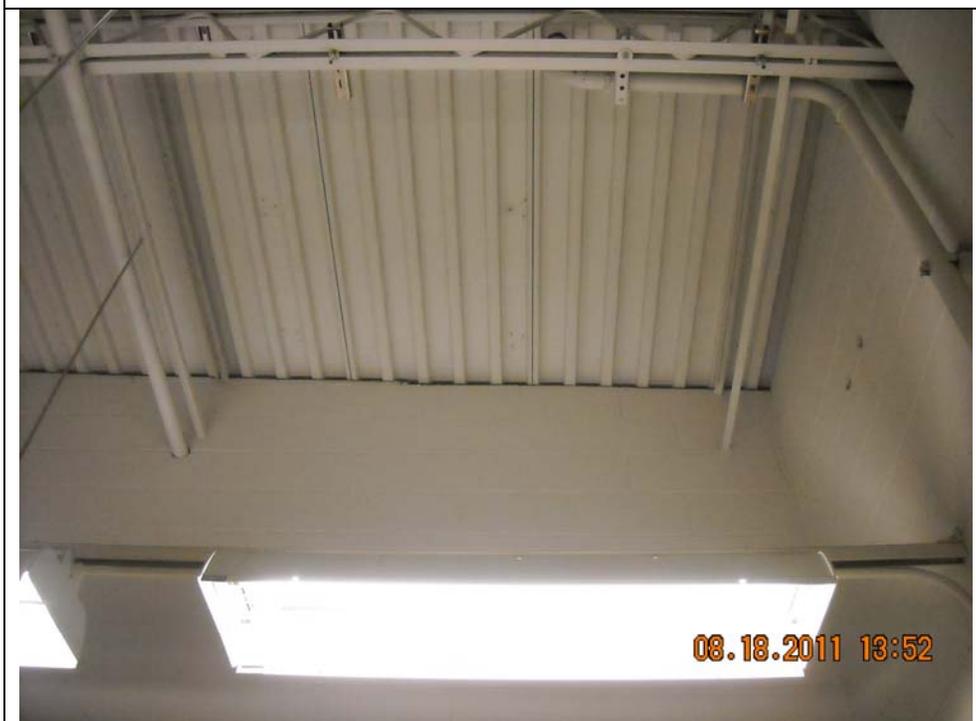
Figure 18 – Wall to roof anchorage not apparent (just gravity connection)

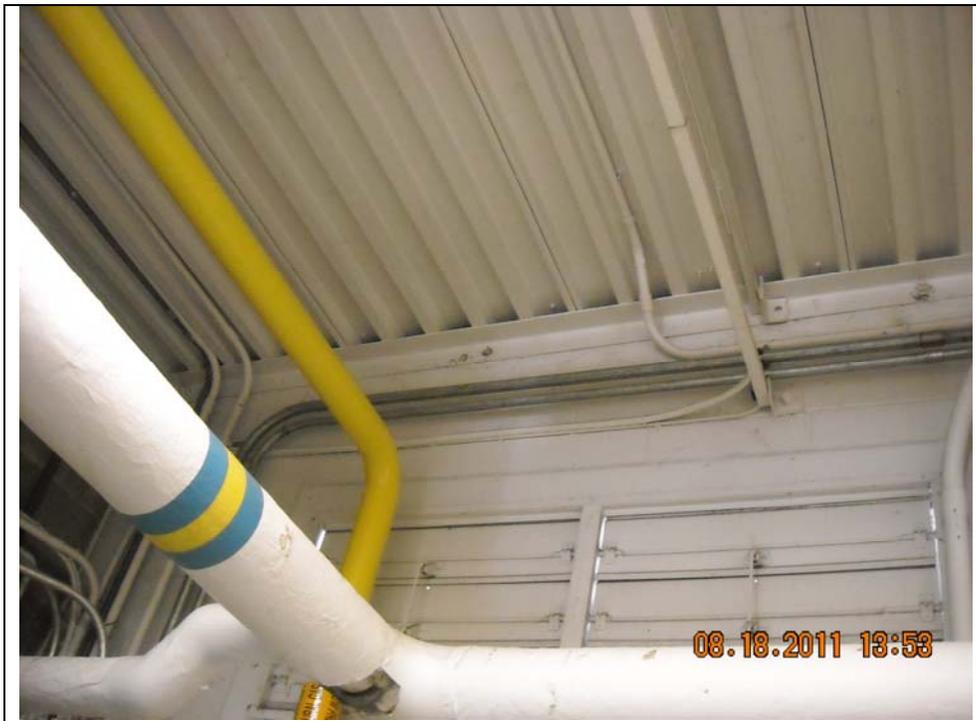
Figure 19 – Diagonal bracing for trusses missing anchor bolt to wall through the ledger

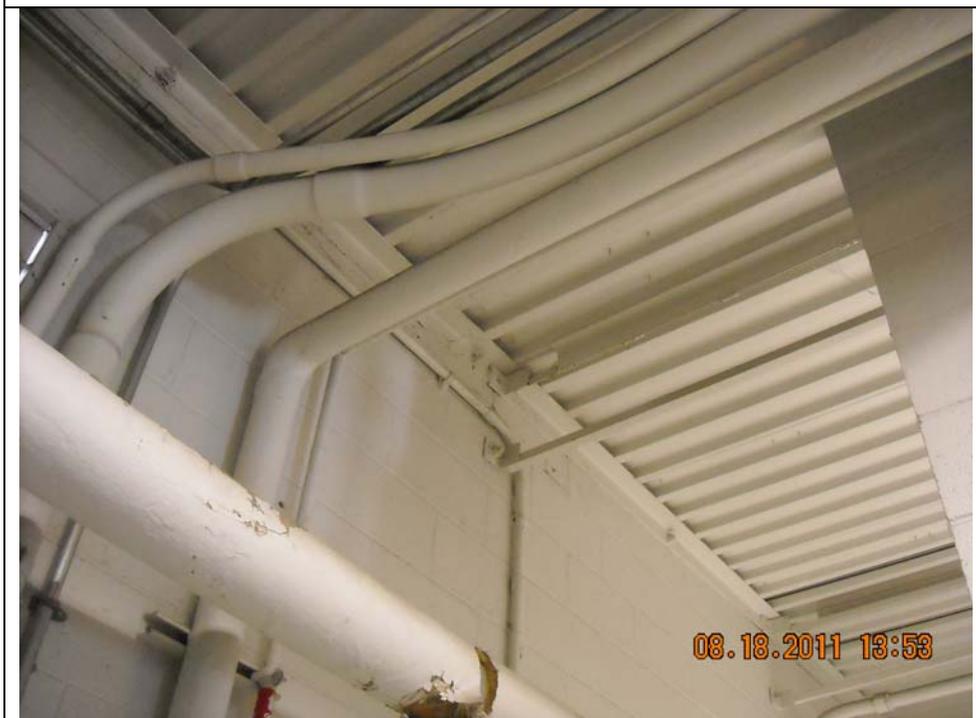
Figure 20 - Diagonal bracing for trusses with narrow plate to wall ledger connection

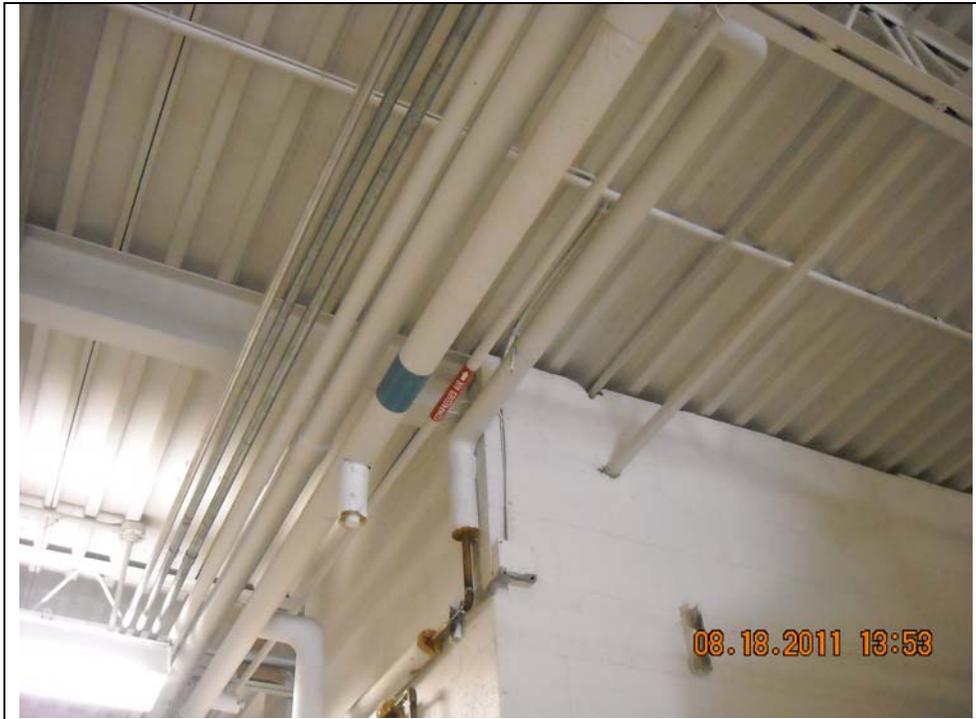
Figure 21 – Steel Collector at shear wall connection is light

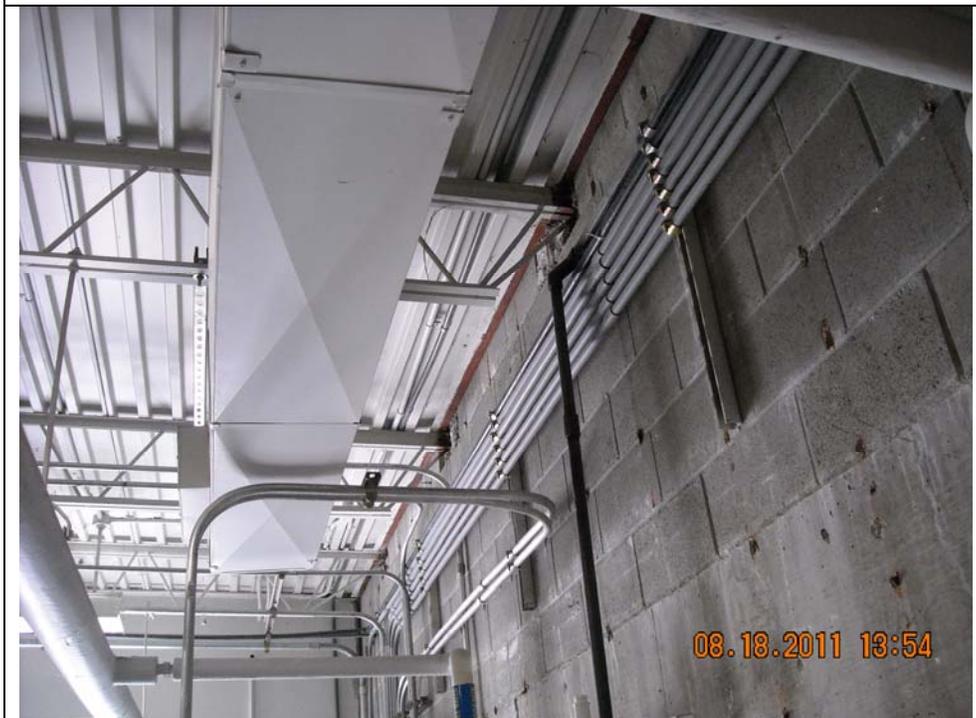
Figure 22 - Honeycombed truss grout pockets

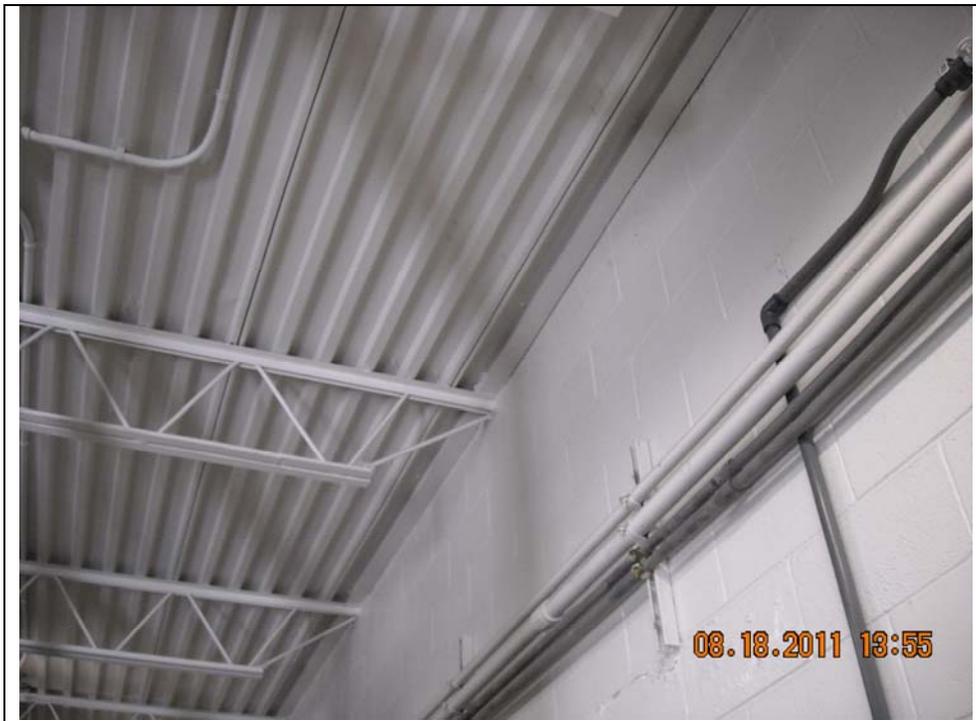
Figure 23 – Steel ledger light attachment to walls

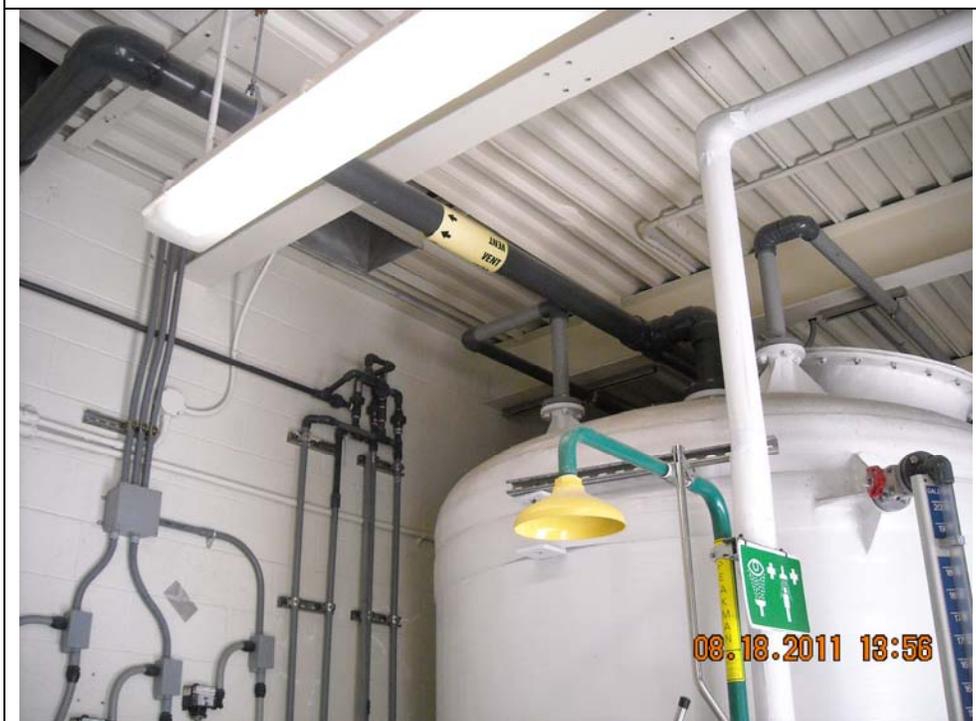
Figure 24 – Steel wide flange to wall connections

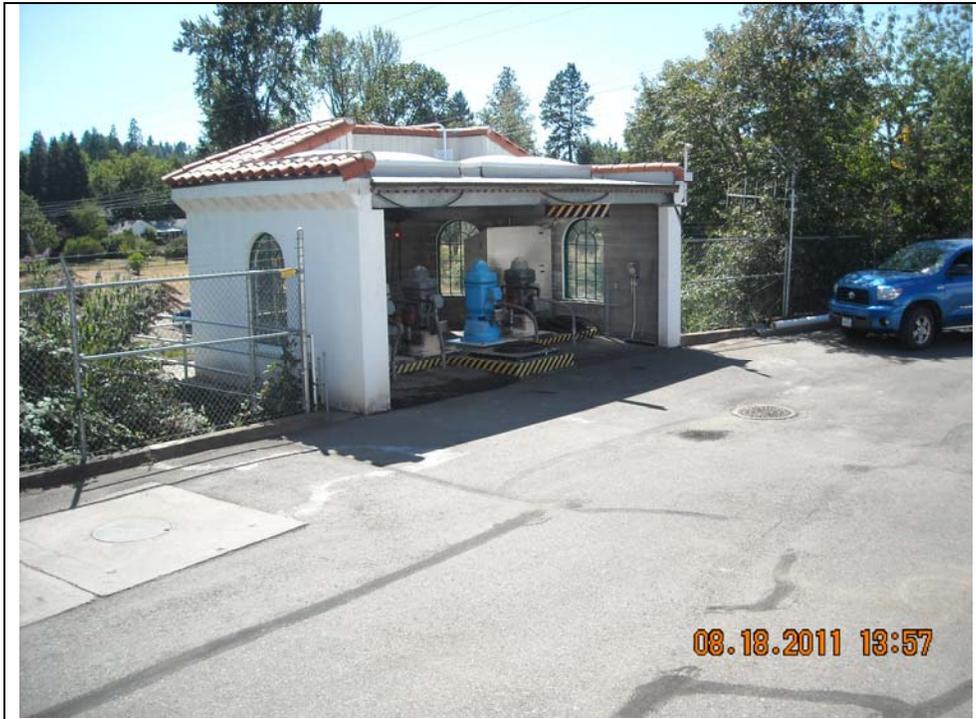
3. The Rogue River intake structure is very tall and laterally loaded by the soil on one side only. During a seismic event, the soil lateral pressure can increase substantially and result in deformation and movement of the intake facility toward the river. This movement can cause failure to the pumps rendering water removal from the river useless until the pump cans are replaced or straightened.

Figure 25 – River Intake Pump Station that will have torsional seismic response

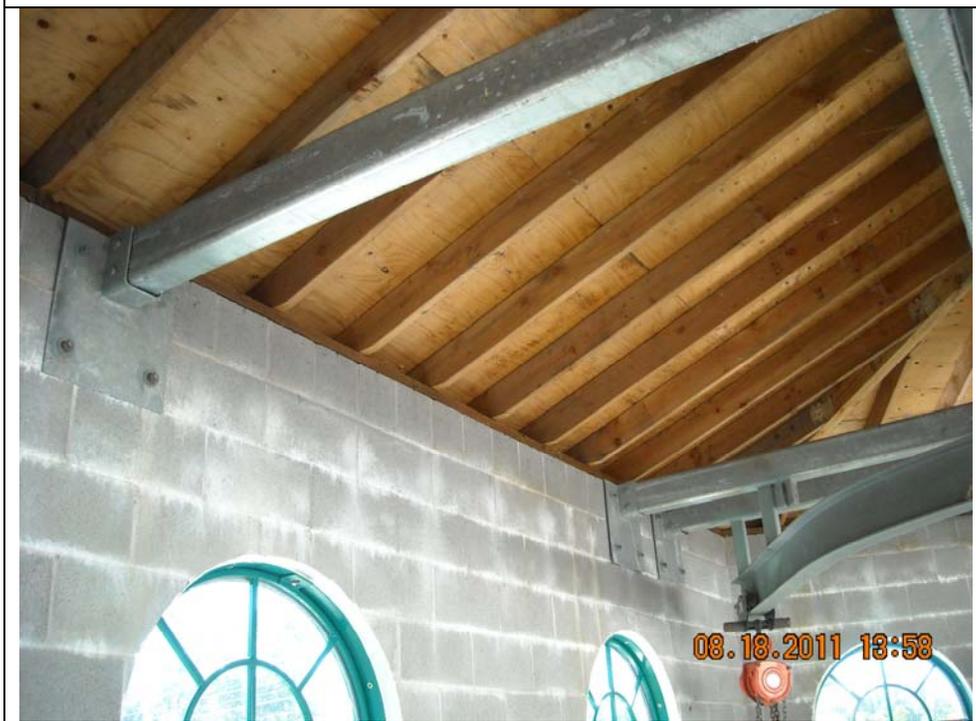
Figure 26 - River Intake Pump Station with light wall to wood roof anchorage

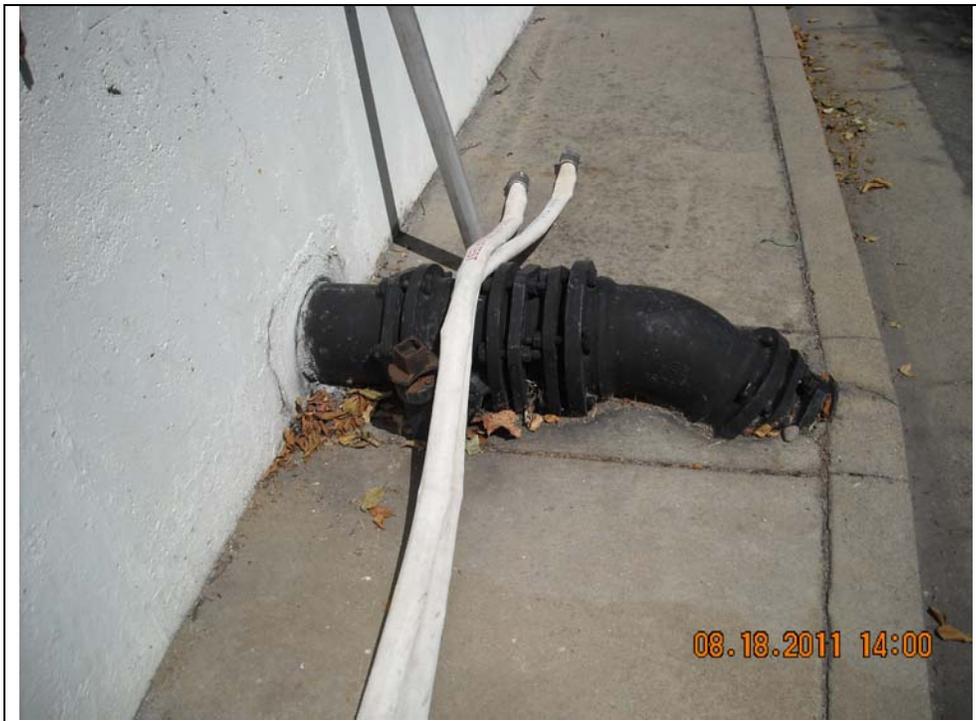
Figure 27 – Rigid piping leading away from Basins that are susceptible to shearing during seismic events

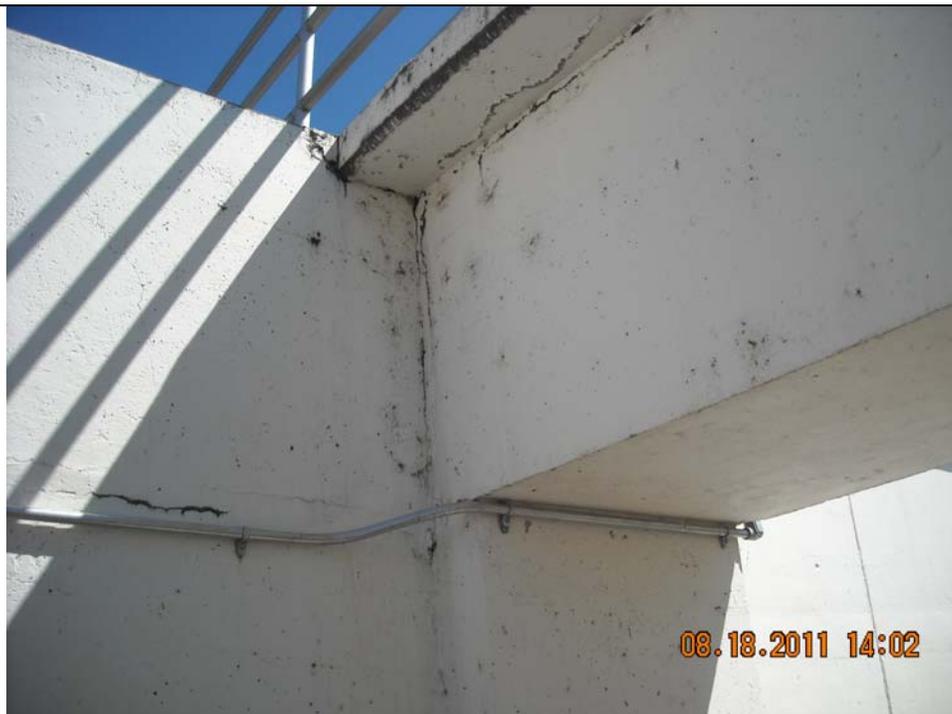
Figure 28 – Cracked concrete water channel between adjacent sedimentation basins

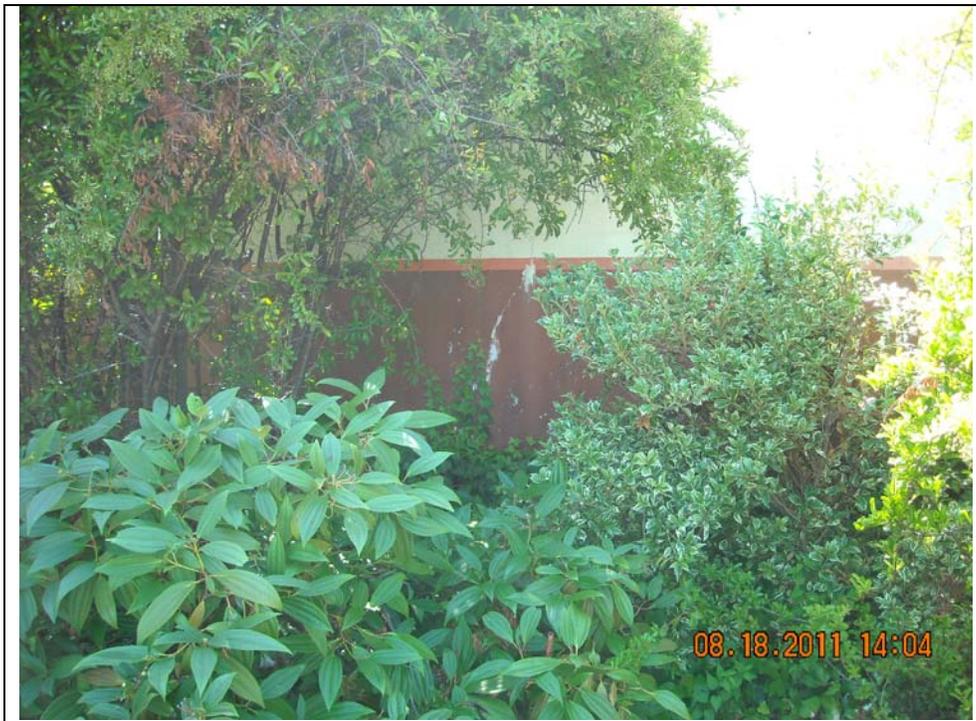
Figure 29 – Vertically cracked sedimentation basin wall

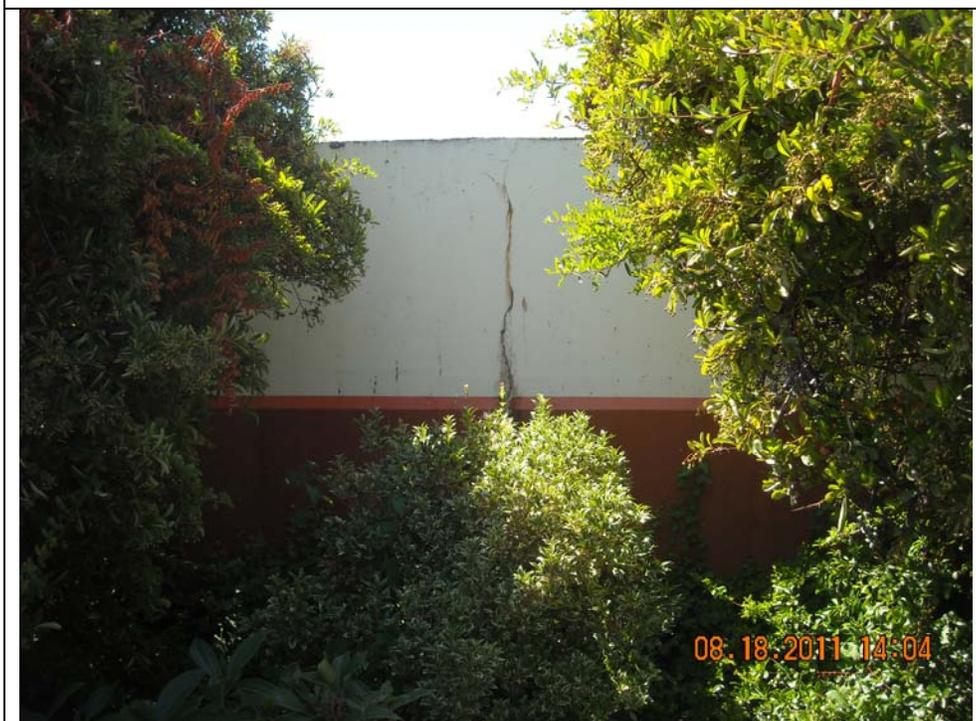
Figure 30 - Vertically cracked sedimentation basin wall

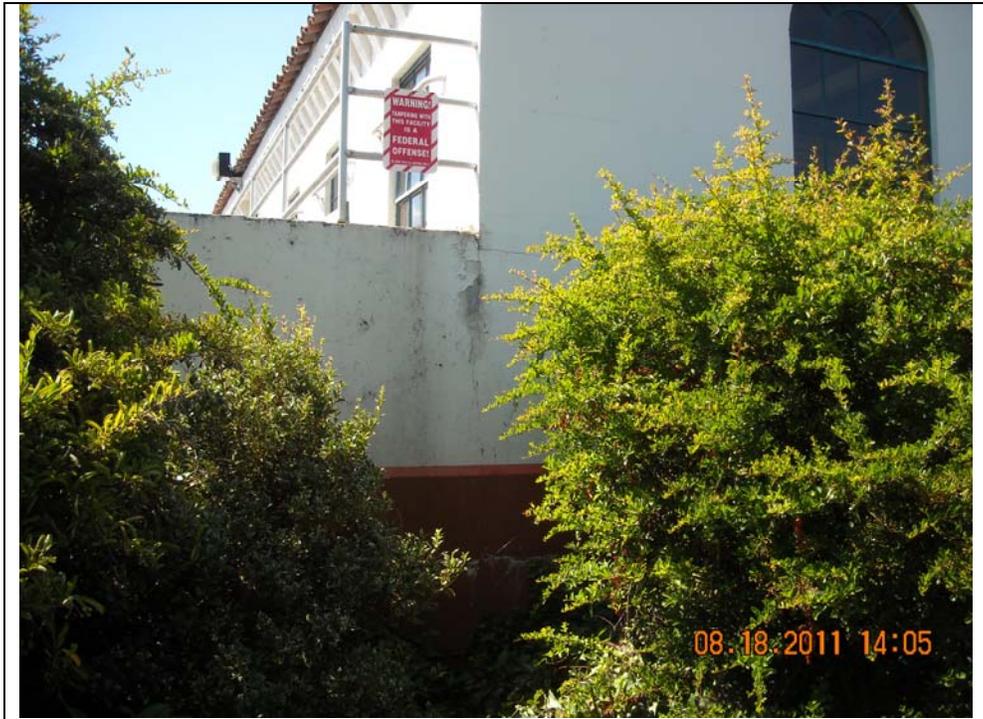
Figure 31 - Vertically cracked sedimentation basin wall at interconnection with filter building
