Structural/Seismic Evaluation, Grants Pass Water Treatment Plant, Grants Pass, Oregon

Final June 28, 2012

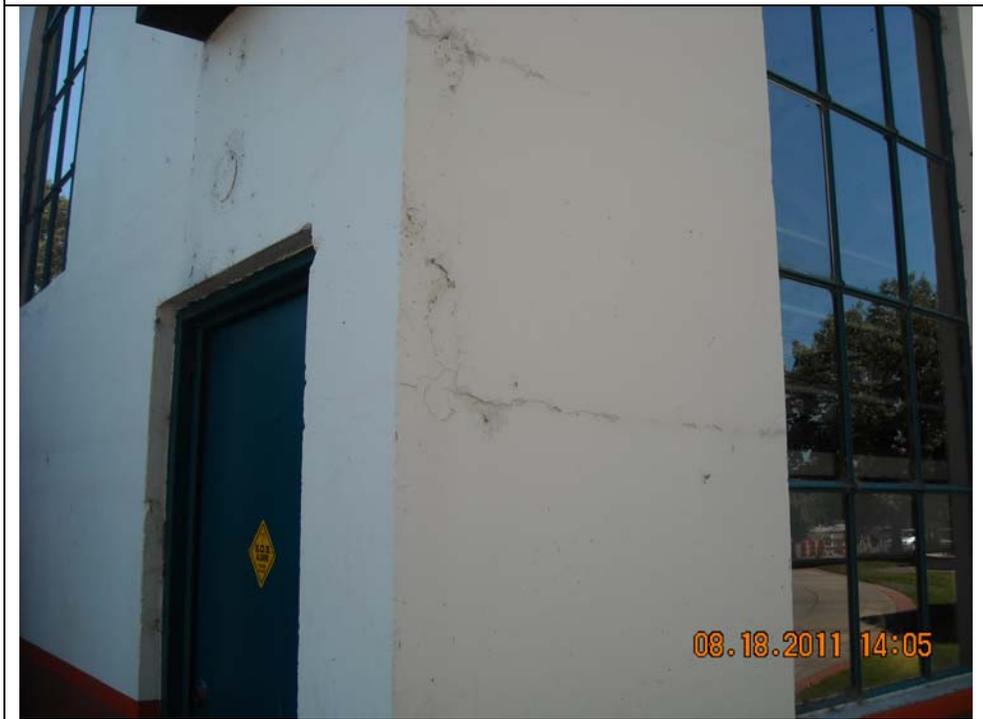
Figure 32 – Horizontally cracked concrete filter building wall

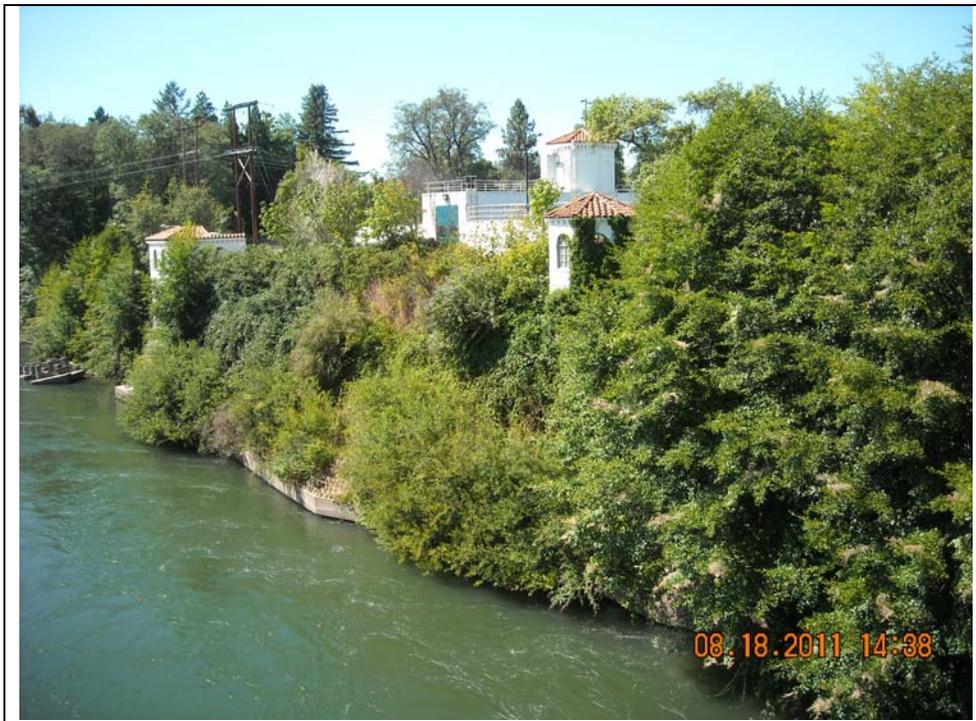
Figure 33 – Rogue River proximity to plant and intake with intake apparently out-of-plumb, slope stability

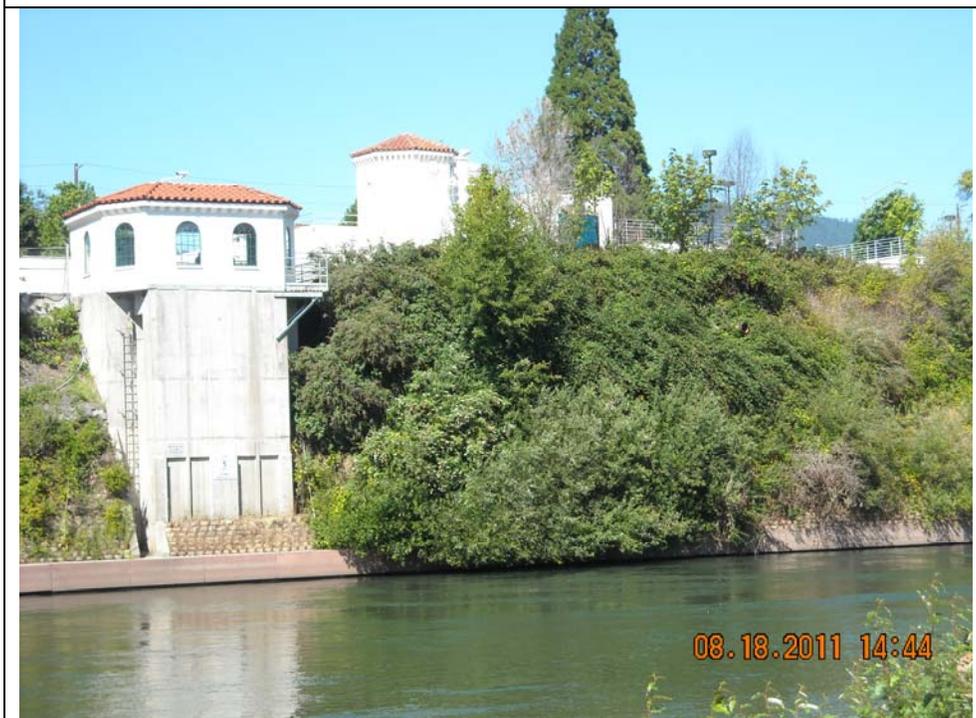
Figure 34 - Rogue River proximity to plant and intake, slope stabilization/remediation present

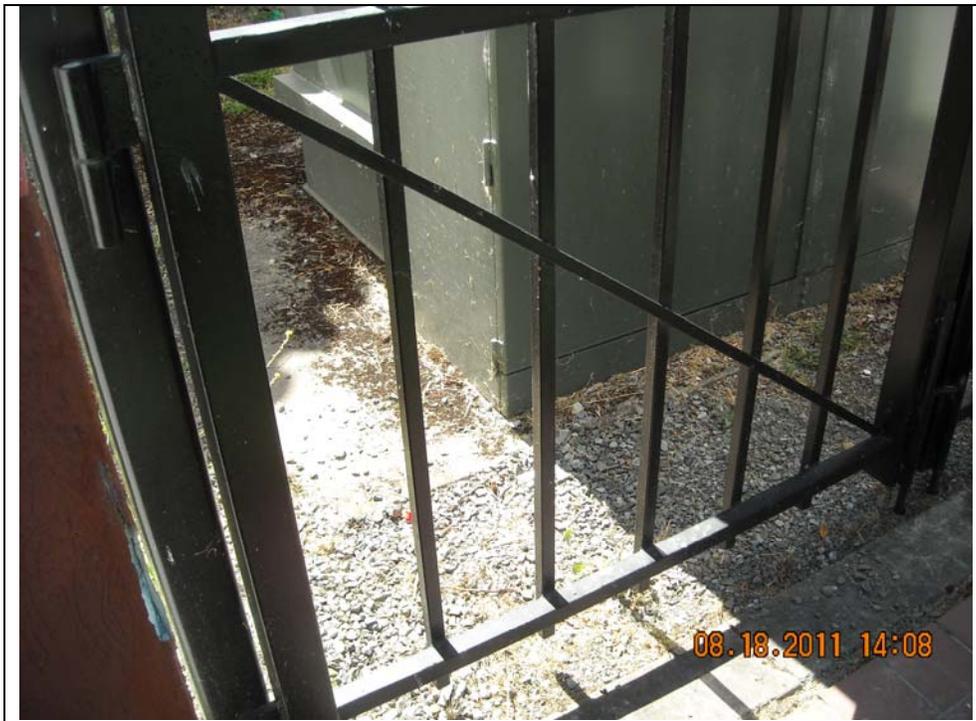
Figure 35 – Transformer Anchorage not visible

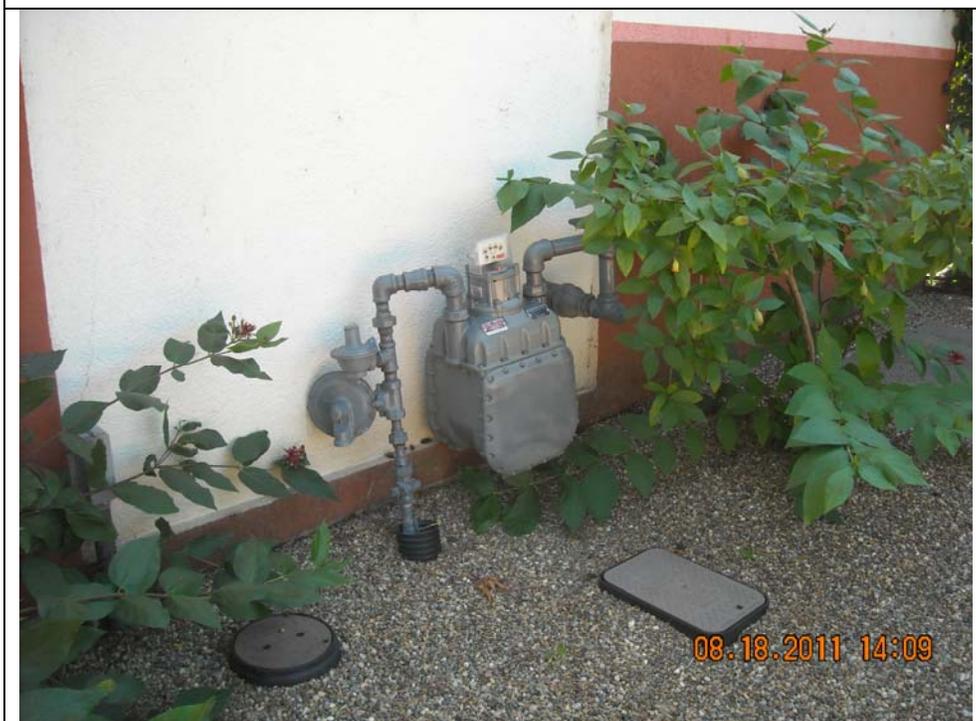
Figure 36 – Gas meter piping narrow pipe sections lack of capacity for ductile movement

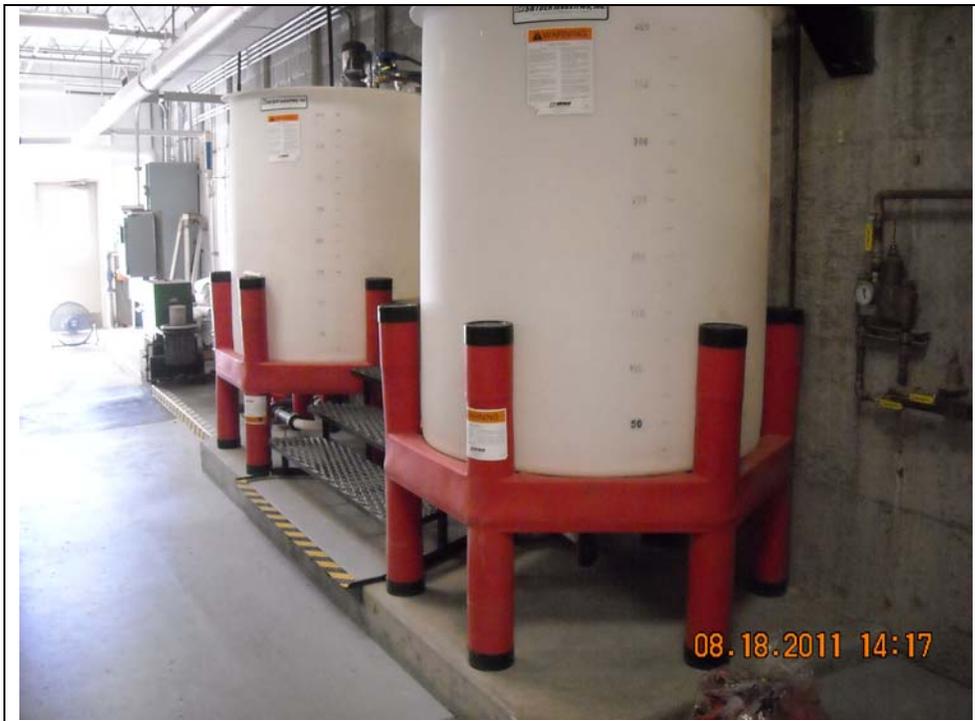
Figure 37 – Poly tank stands lack of anchorage for lateral sliding and overturning

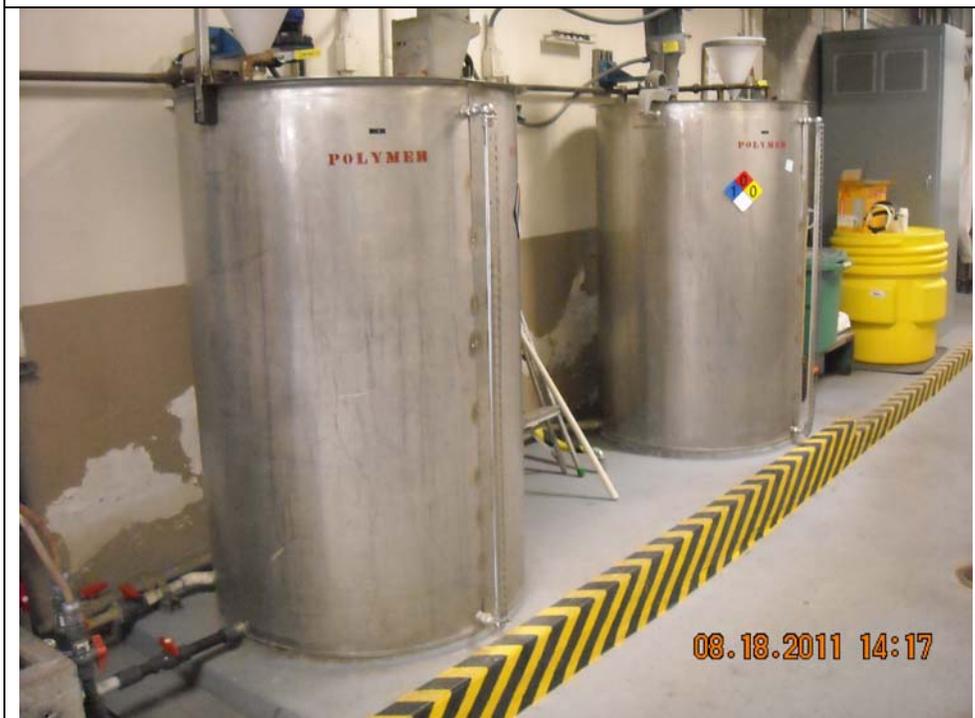
Figure 38 - Polymer tanks lack of anchorage for lateral sliding and overturning

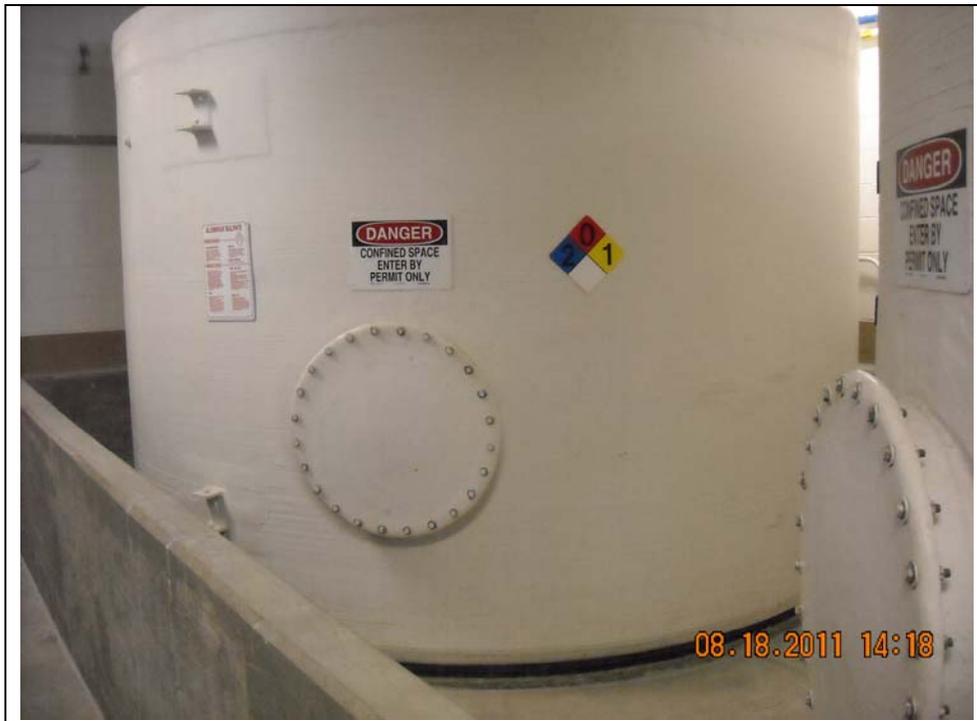
Figure 39 – Aluminum Sulfate and T-Floc tanks lack of anchorage for lateral sliding

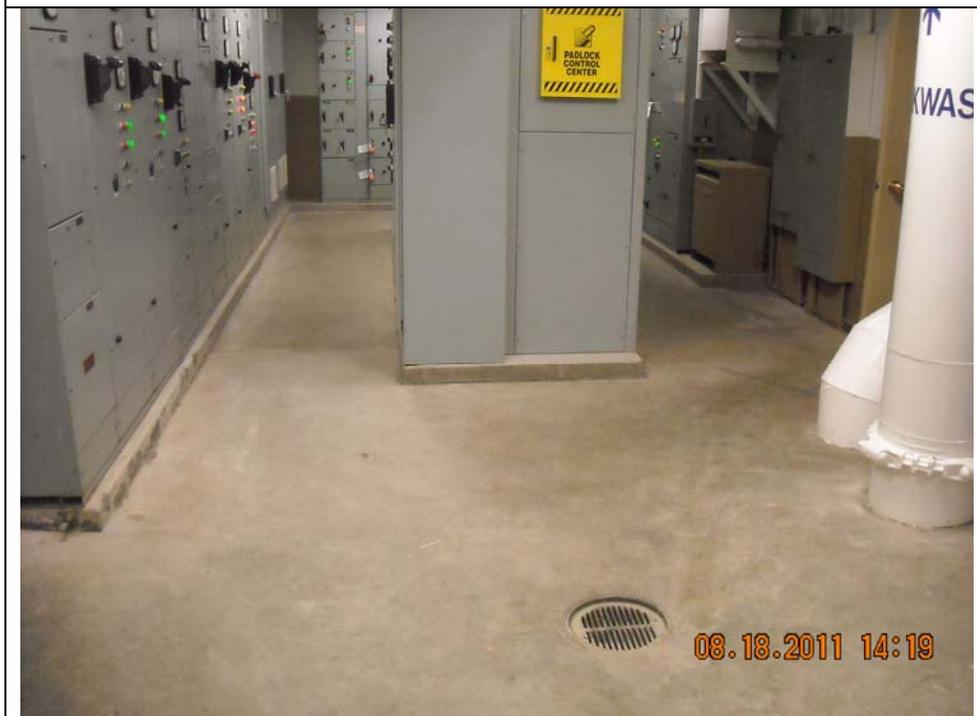
Figure 40 - Electrical Equipment Narrow Pads have limited lateral sliding resistance availability

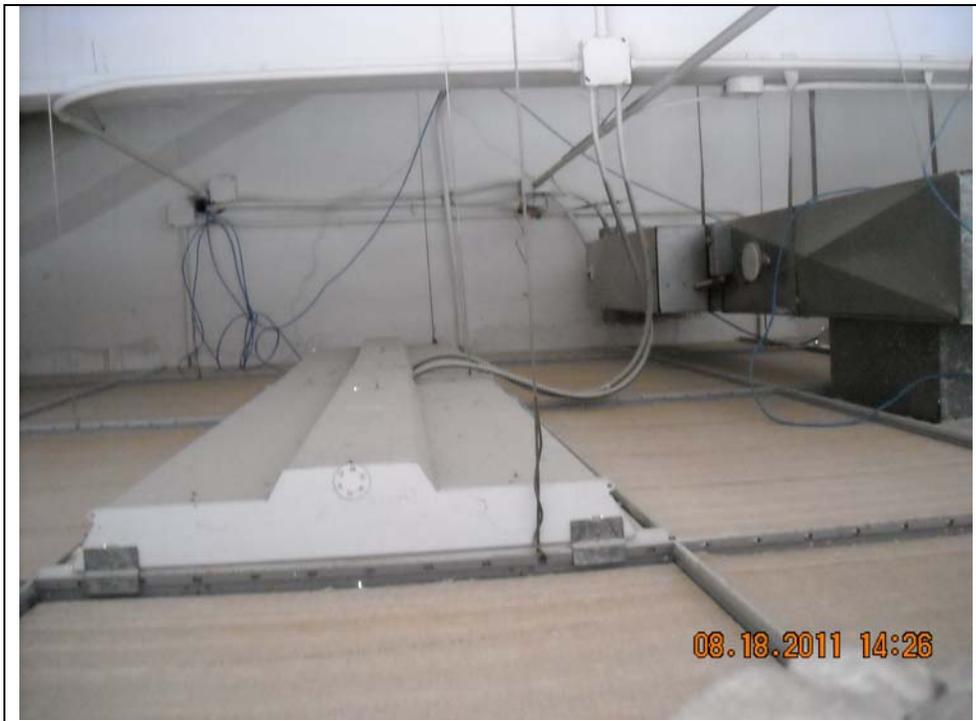
Figure 41 – T-bar ceiling, lighting and HVAC ducts missing lateral splayed wires and compression struts

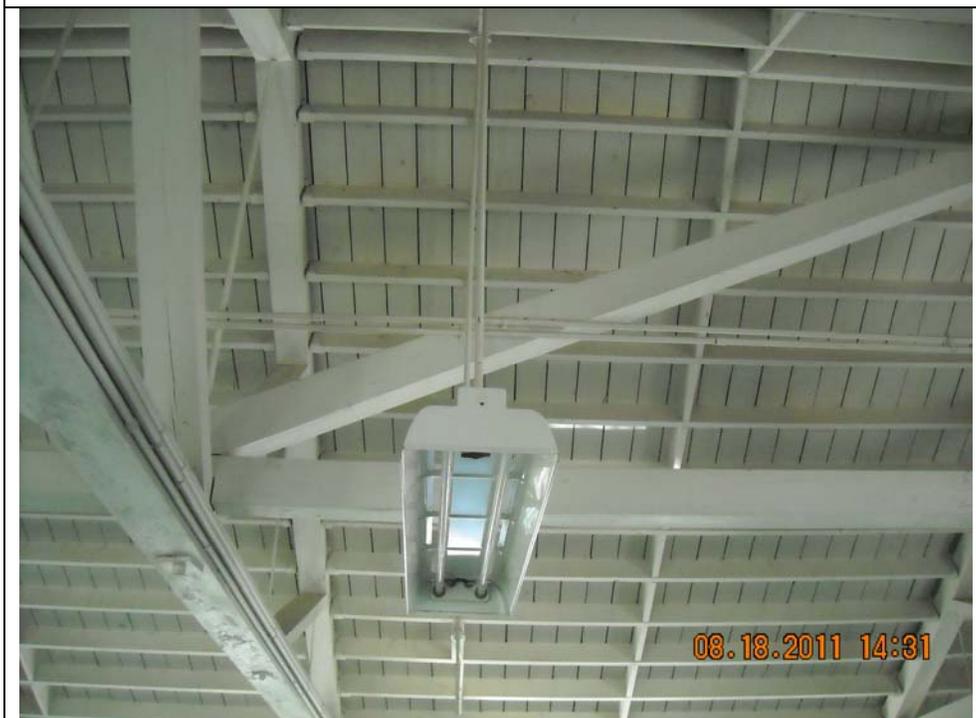
Figure 42 - Lighting missing lateral splayed wires and compression struts
