Memorandum

Date: January 23, 2019

Project: Task Order No. 34, Facility Structural Assessments

Re: Water Infrastructure Capital Maintenance Plan

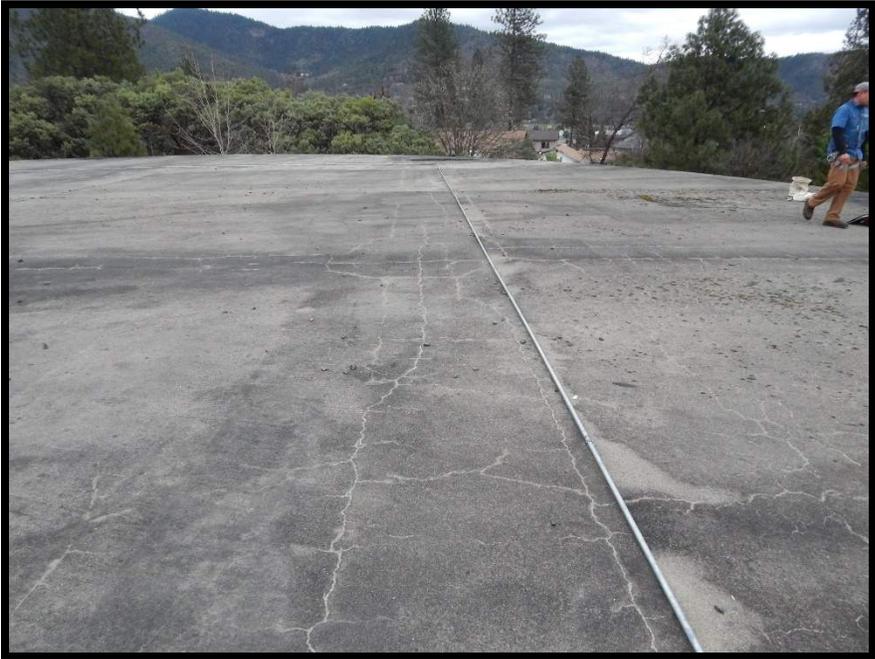
Figure 3-9: Roof Joint & Typical Cracking

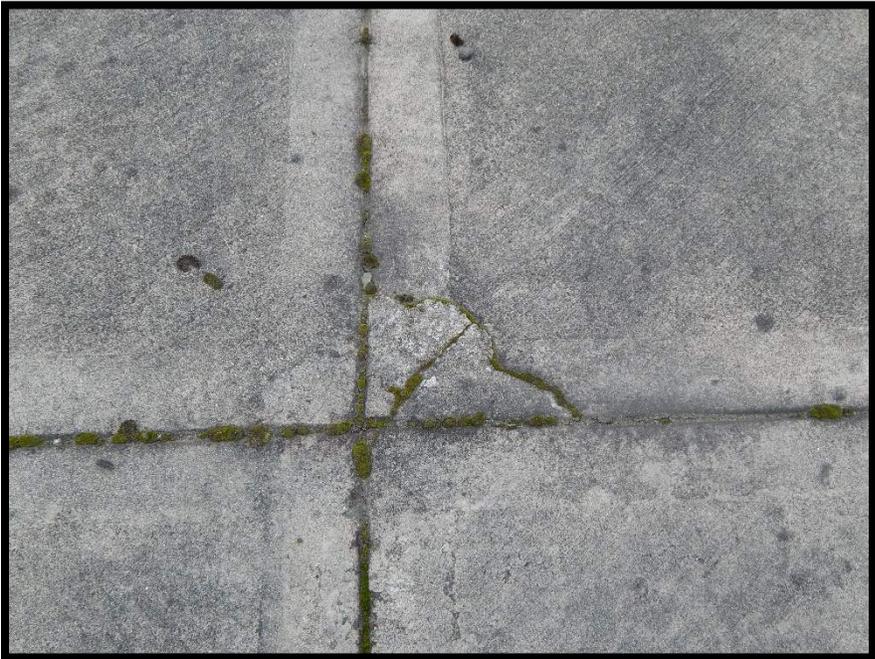
Figure 3-10: Crack at Roof Joint Intersection

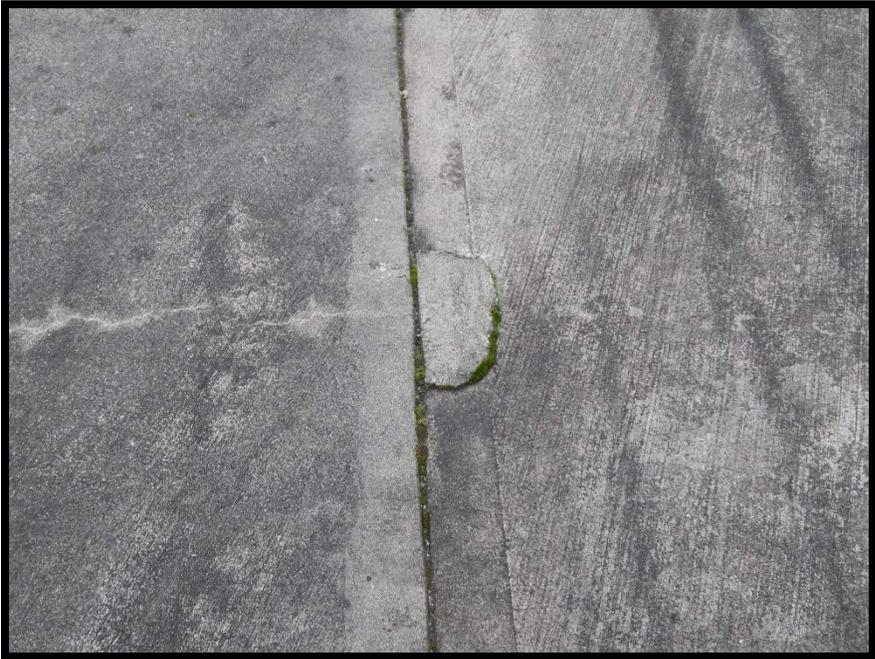
Figure 3-11: Cracking/Spall at Roof Joint

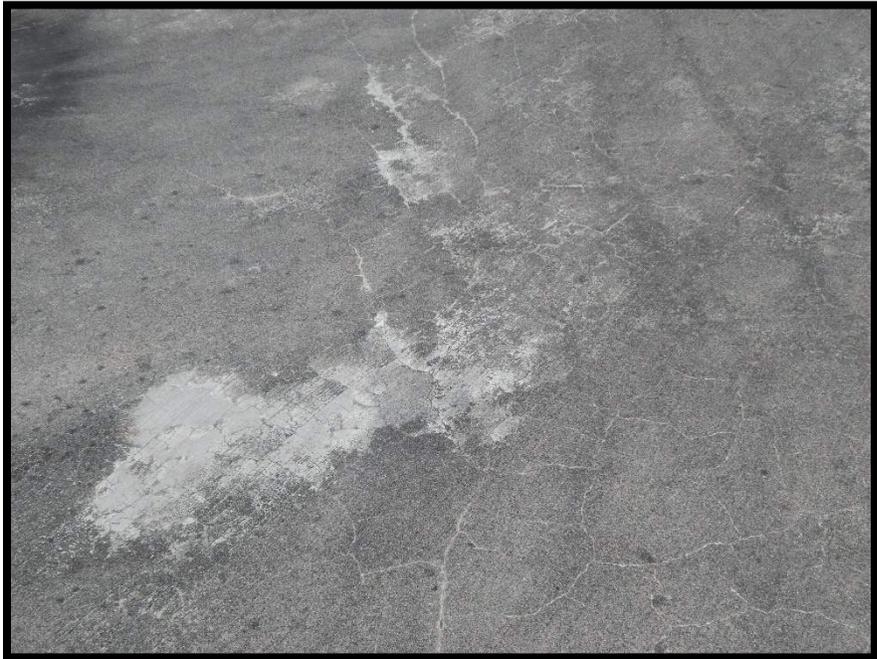
Figure 3-12: Typical Cracking in Roof Slab

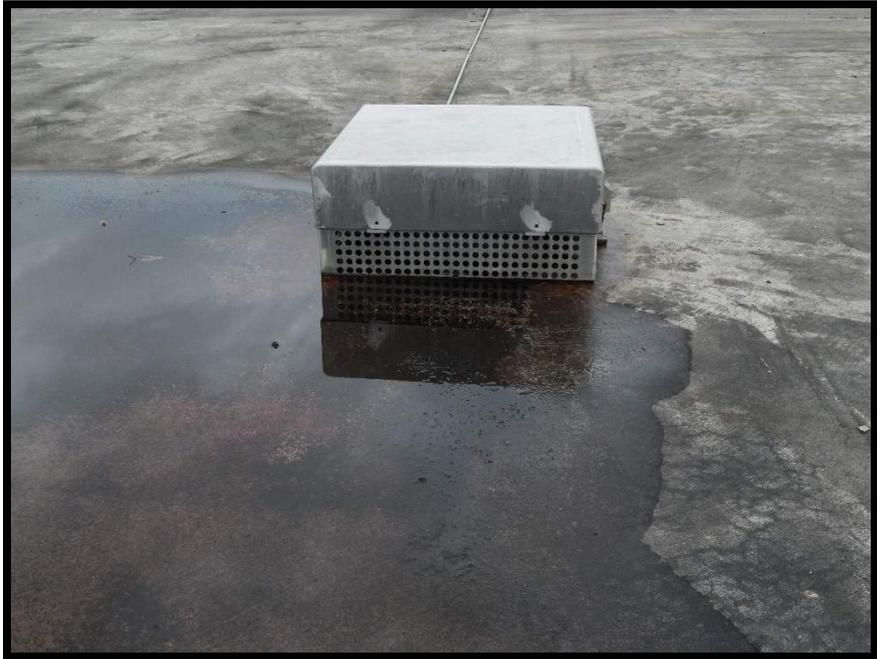
Figure 3-13: Roof Vent & Ponding

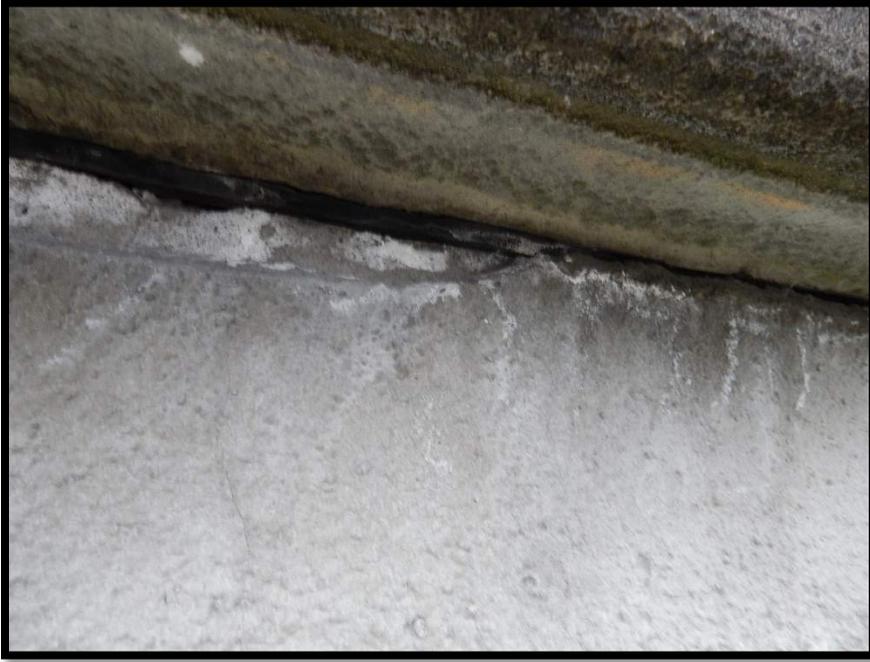
Figure 3-14: Spalled Concrete at Top of Wall to Roof Joint

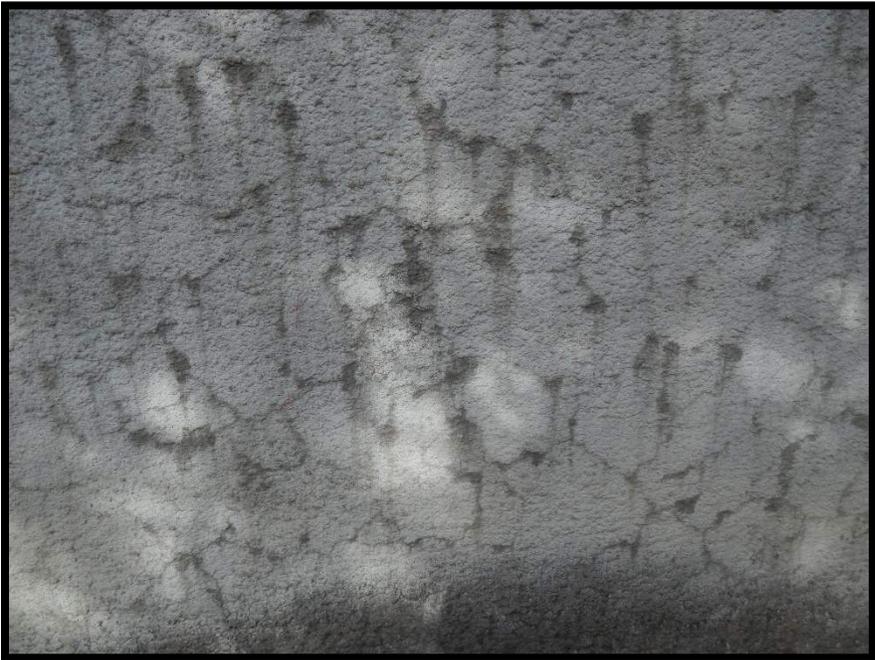
Figure 4-6: Typical Cracking in Shotcrete

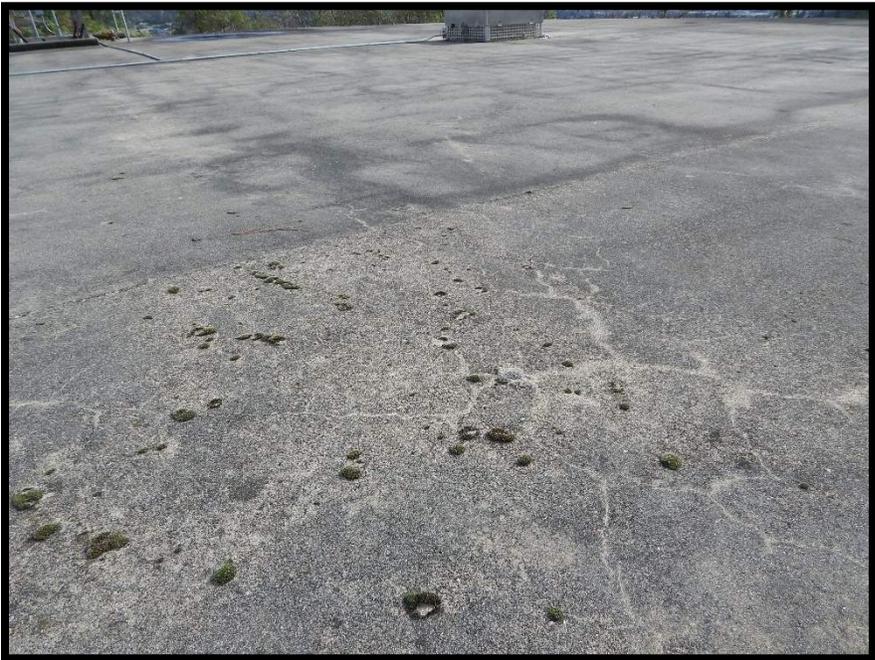
Figure 4-7: Typical Roof Cracking

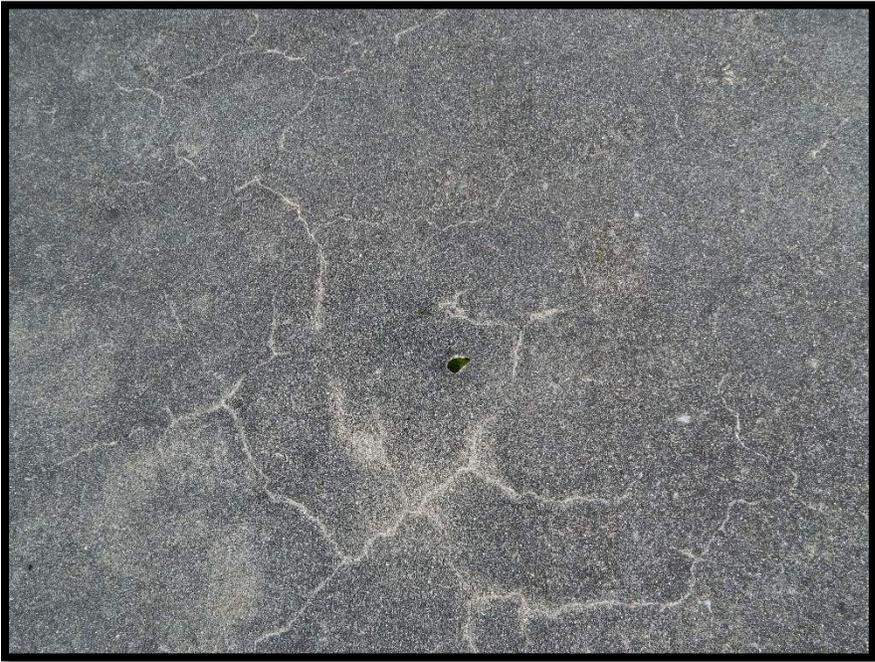
Figure 4-10: Typical Roof Cracking & Small Rock Pocket (Filled with Dirt & Moss)

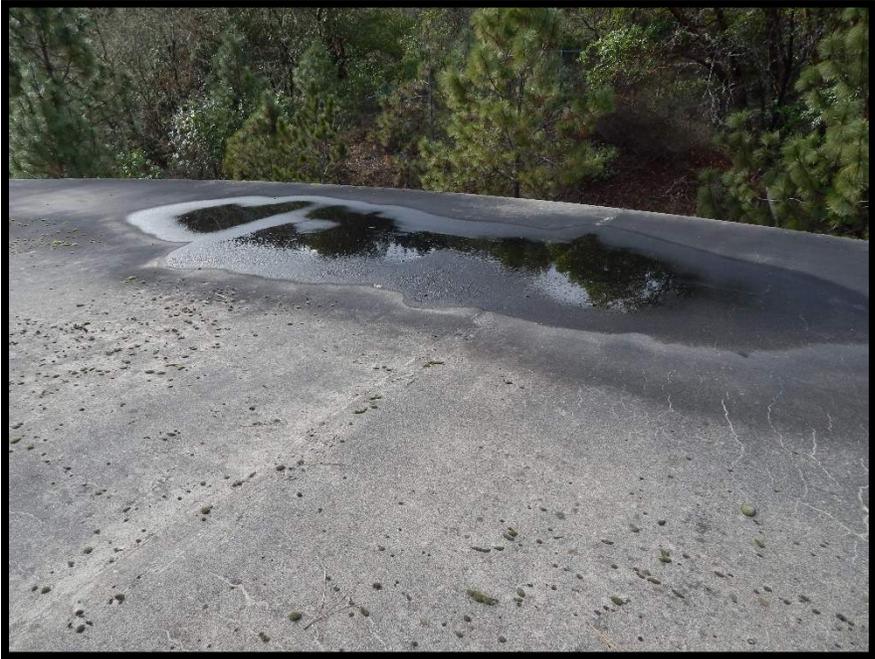
Figure 4-11: Typical Ponding at Quadrants

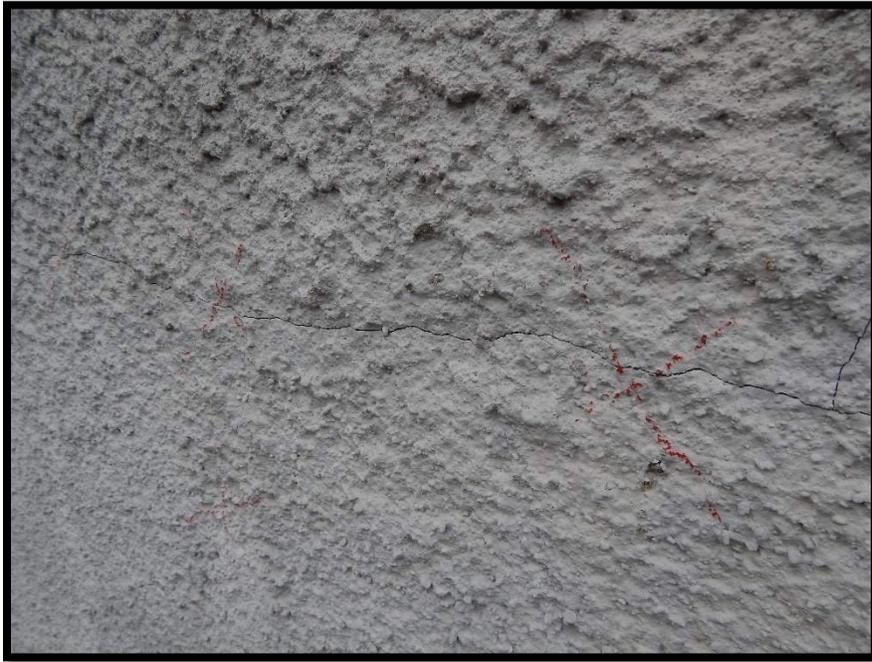
Figure 5-9: Typical Cracks in Shotcrete

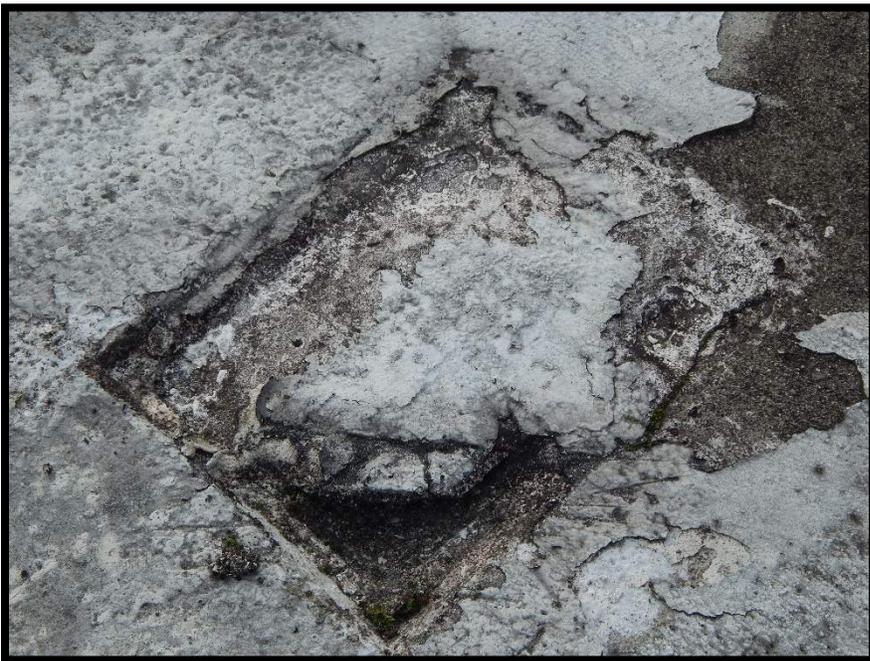
Figure 5-12: Shear Can w/ Deteriorated Infill

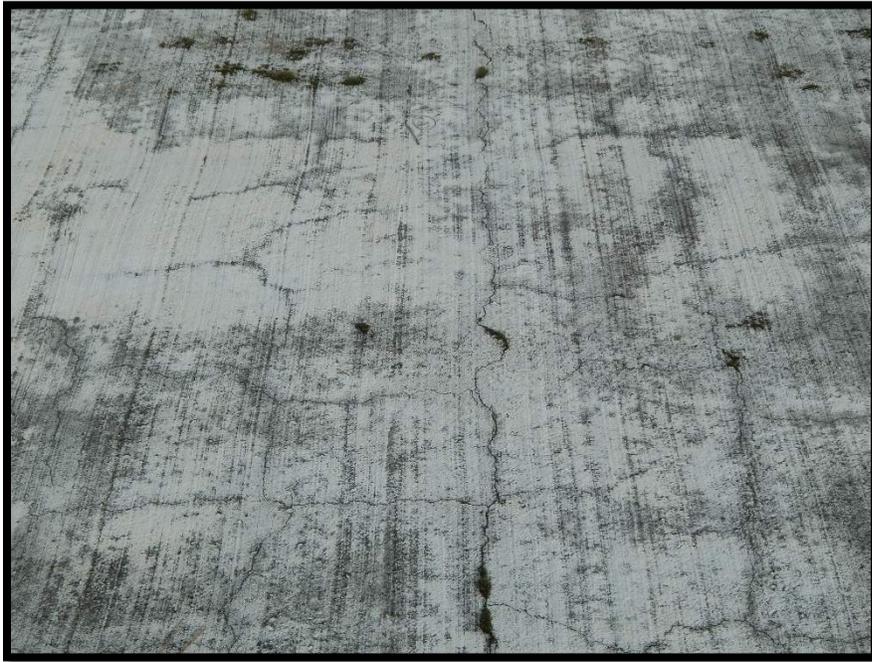
Figure 5-15: Typical Roof Cracking

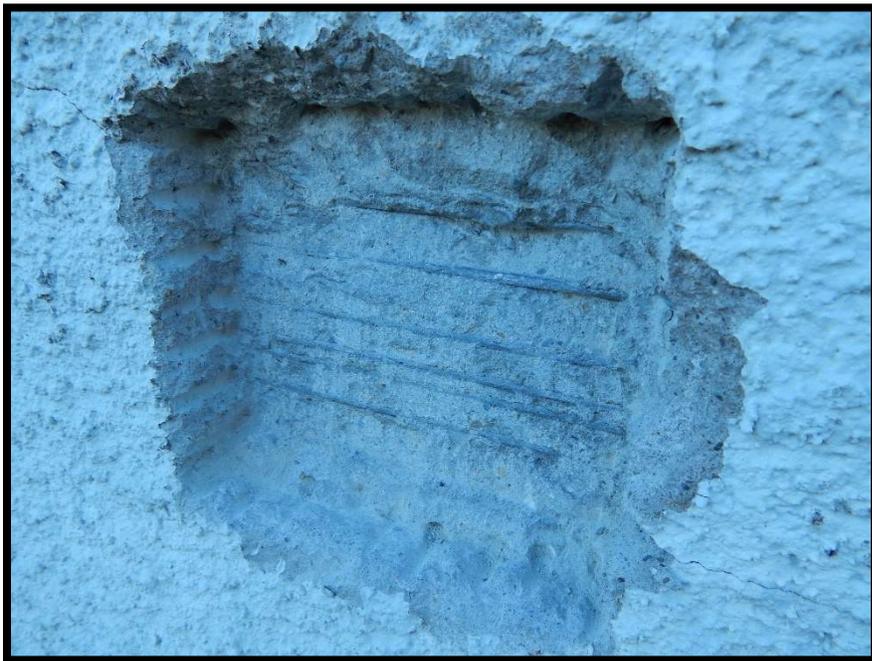
Figure 5-16: Exposed Wire Pre-stressing – Location 1

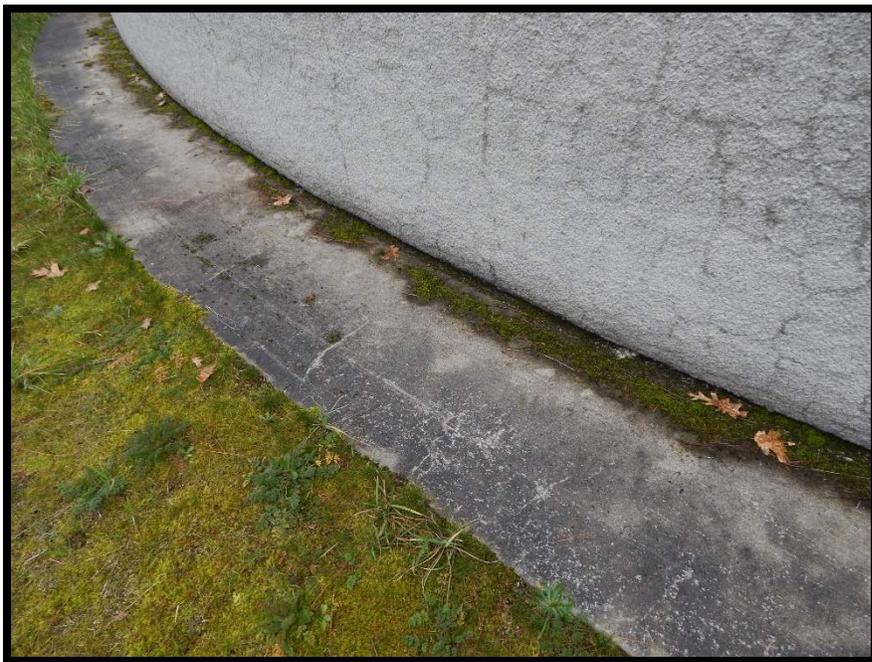
Figure 6-10: Top of Footing & Reservoir Wall Base w/ Typical Cracking

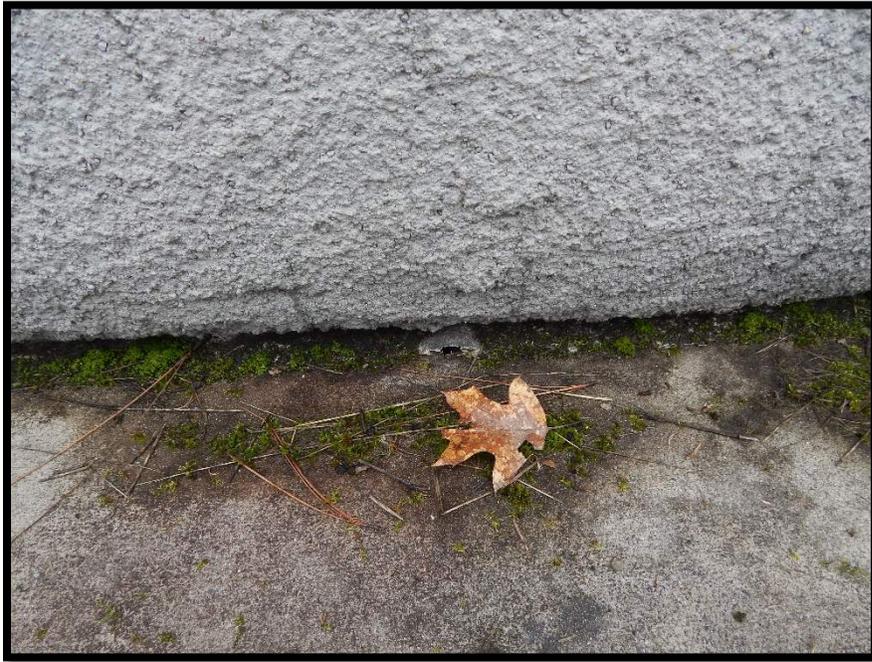
Figure 6-11: Wall Base w/ Sealant Hole

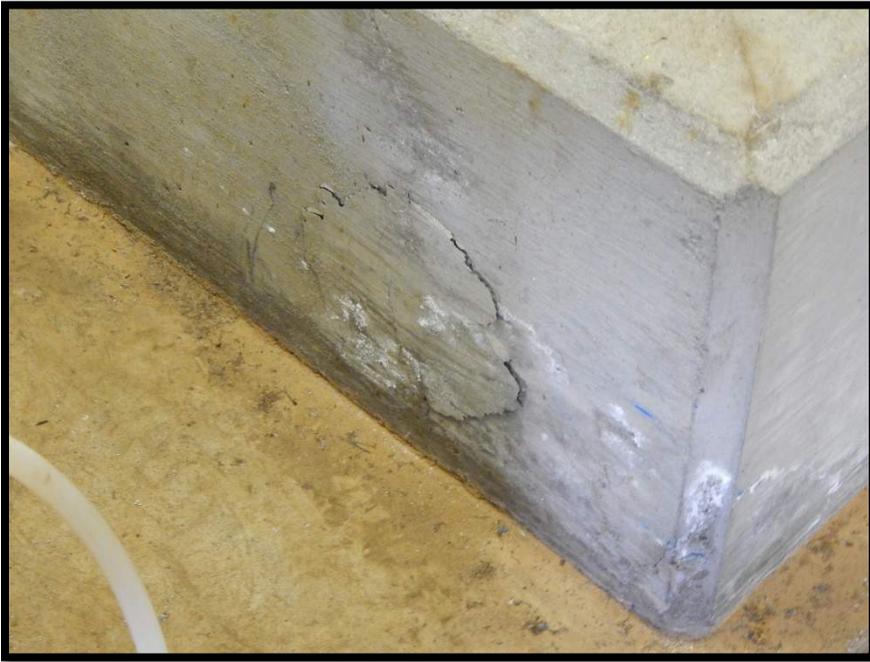
Figure 7-9: Cracked/Spalled Pump Base

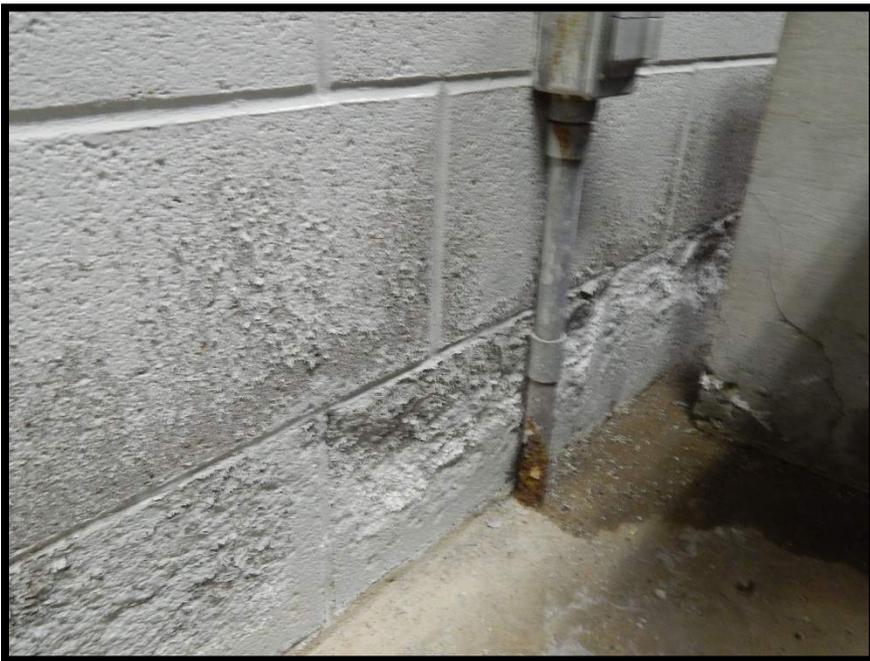
Figure 7-10: Chlorine Damaged CMU & Cracked Pump Base

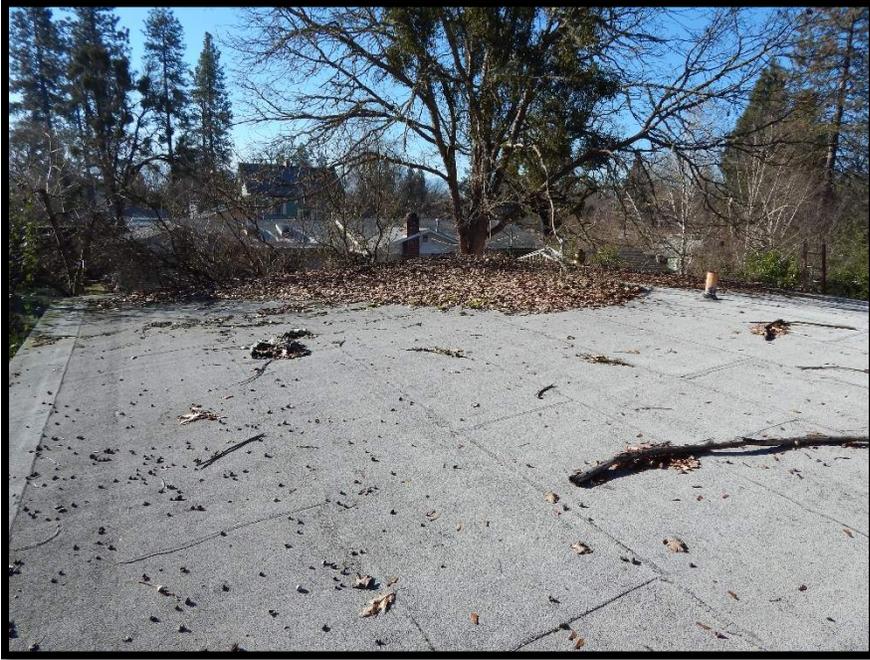
Figure 7-11: Roof w/ Organic Debris

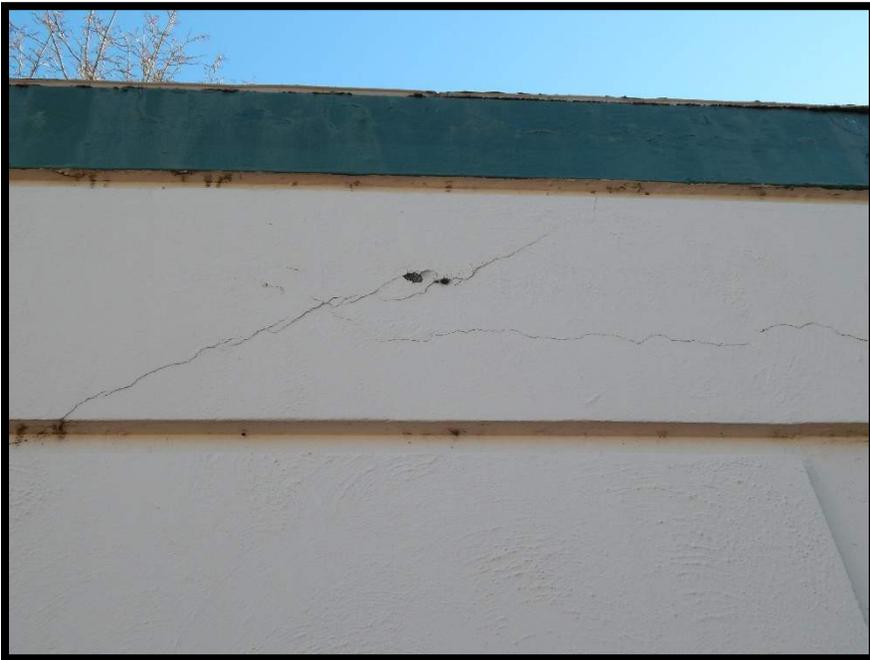
Figure 8-4: Typical Cracking at Exterior

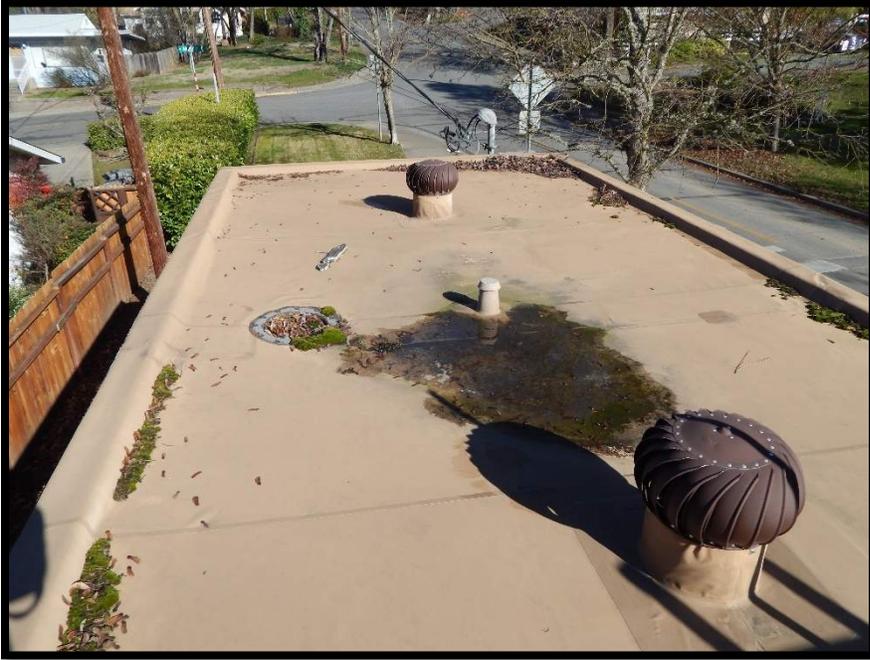
Figure 8-5: Roof Ponding & Central Drain

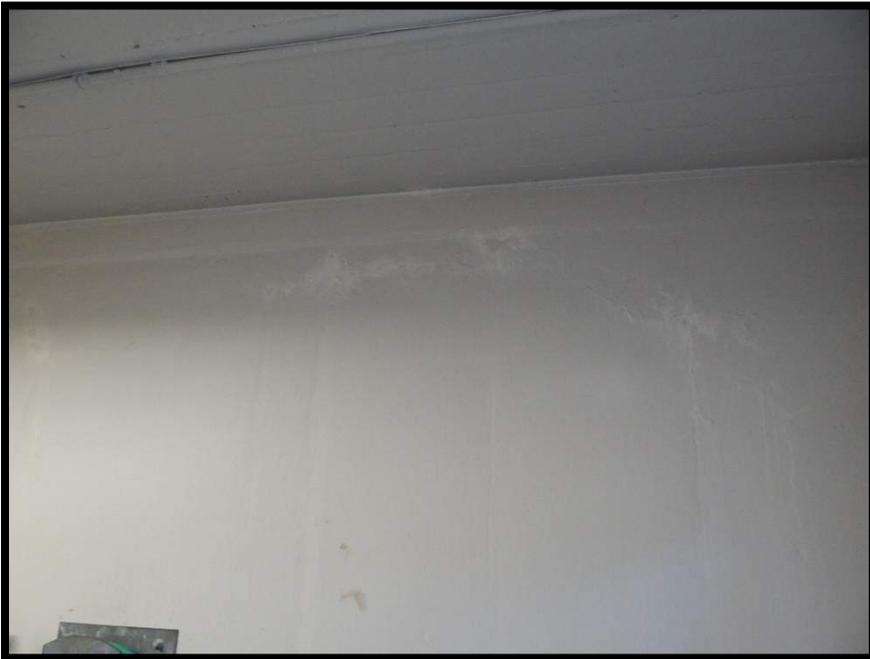
Figure 8-6: Repaired Interior Cracking

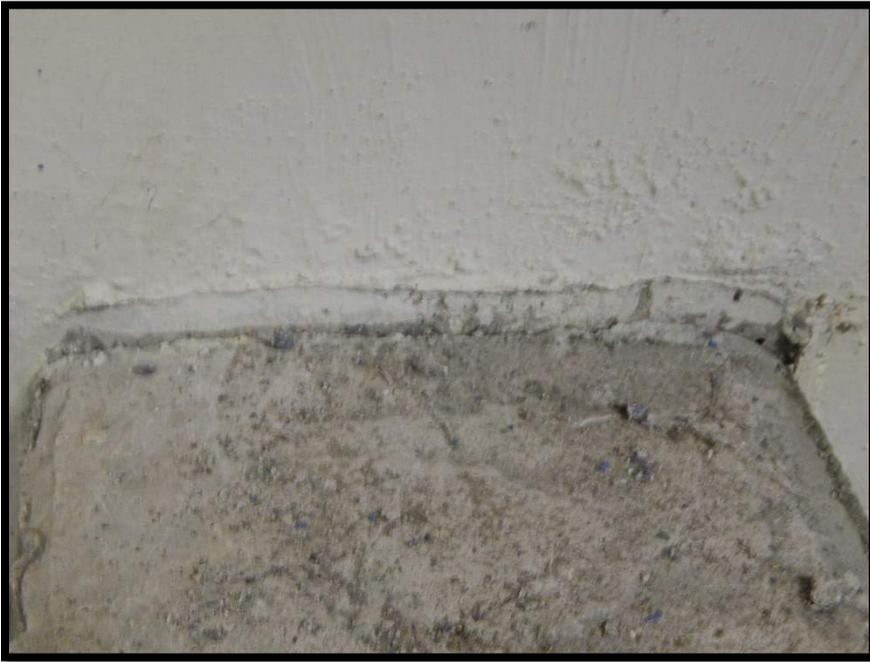
Figure 8-7: Differential Settlement at Pump Base

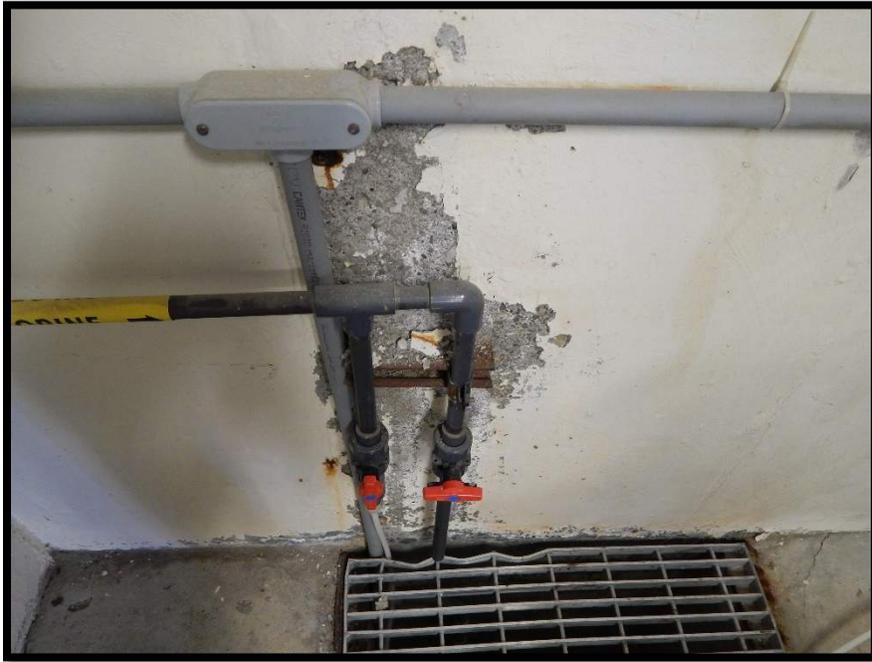
Figure 8-9: Concrete Damage

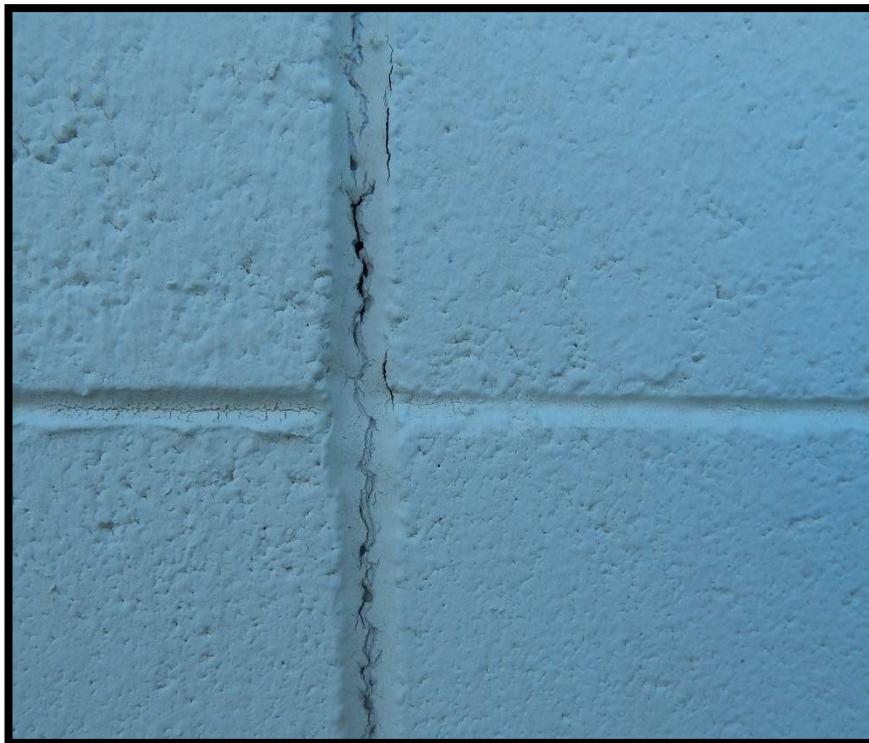
Figure 9-5: Cracked Sealant at Vertical Construction Joint

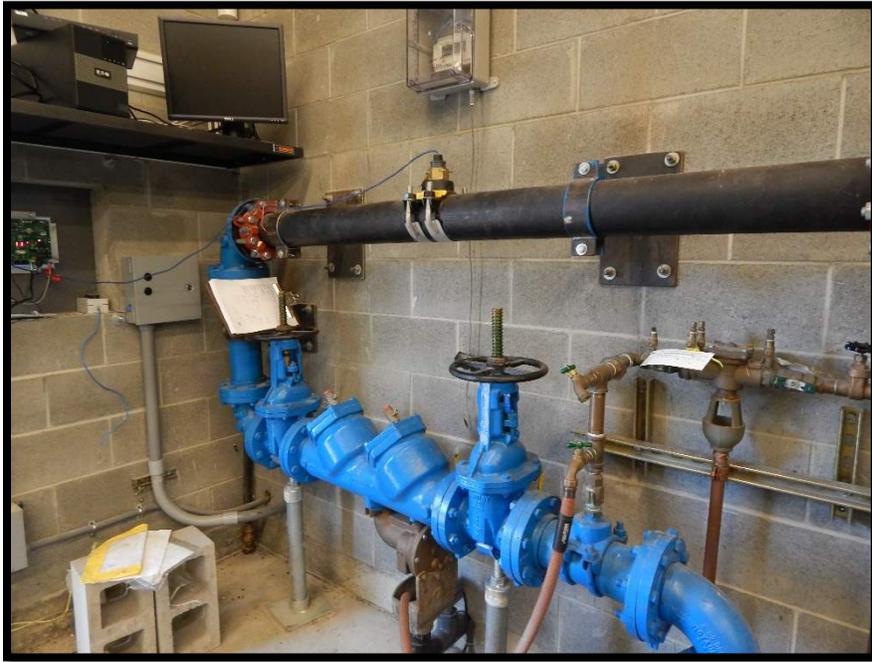
Figure 9-5: New penetration added for water filling station (Top left of Photo)

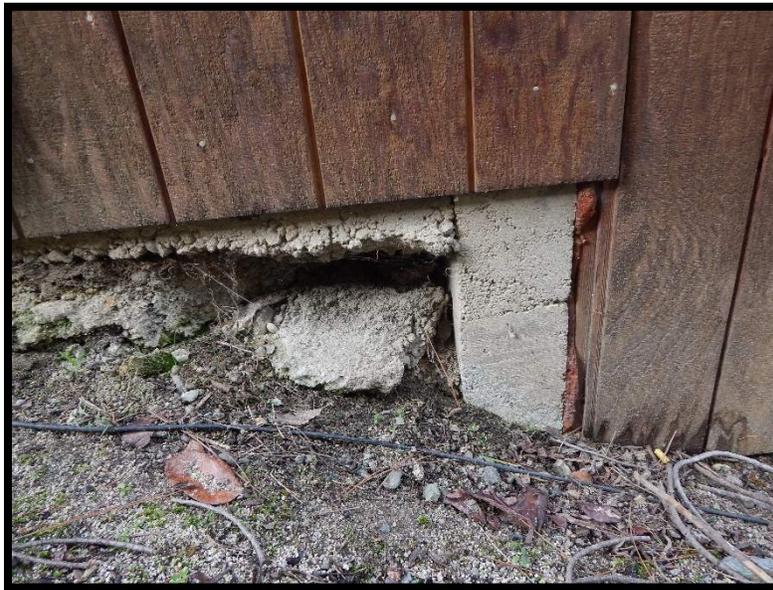
Williams crossing is a clamshell style pump station, which has had a conventional light frame wood enclosure stick framed around it on a concrete slab. Within the enclosure is a small pressure tank as well which is bolted down to the slab. The clamshell pump station appears to be in good condition and no structural concerns were noted during the visual inspection. The wood enclosure structure appears to be in good condition. It was noted that the surrounding grade is in contact with the wood siding which may cause damage to the wood. In addition, one area of the concrete slab/footing is being undermined. It is recommended that the grade be adjusted as needed in these areas.

Figure 10-1: Grading Issues

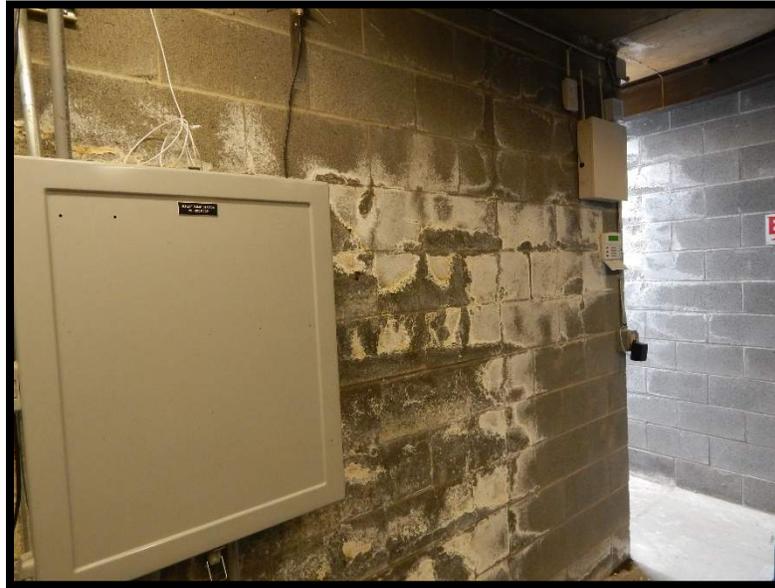
Hefley pump station is a partially buried pump station built circa 1996 per the City. The pump station is CMU walls with a concrete floor and concrete slab roof. The pump station is accessed through a Bilco style hatch on the side of the pump station. The exterior of the pump station appears to be in good condition with no structural issues noted. Similarly, the interior of the pump station appears to be in good condition. There is a substantial amount of efflorescence built up on several of the walls. This doesn't appear to be a structural concern at this time. This may have occurred shortly after construction or may be indicative of water transmission through the walls. We recommend cleaning the walls of efflorescence to see if it returns which would be indicative of transmission through the walls that may need to be addressed. If

Figure 10-2: Efflorescence through CMU walls

moisture is transmitting through the walls it is recommended that this be addressed to prevent potential damage to the reinforcing steel within the walls.
