Structural/Seismic Evaluation, Grants Pass Water Treatment Plant, Grants Pass, Oregon

Final June 28, 2012

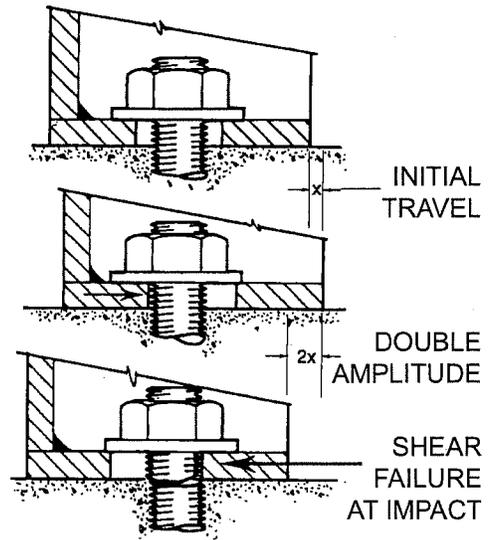
IMPACT SHEAR FAILURE

When there is excessive clearance between anchor bolts and equipment holes, the equipment has a tendency to shear off the anchor bolts during earthquakes or bomb blasts at accelerations as low as 0.2 G. The reason as explained in the figure is a velocity buildup because of sliding. What was initially analyzed as a static system becomes dynamic.
