Memorandum

Date: January 23, 2019

Project: Task Order No. 34, Facility Structural Assessments

Re: Water Infrastructure Capital Maintenance Plan

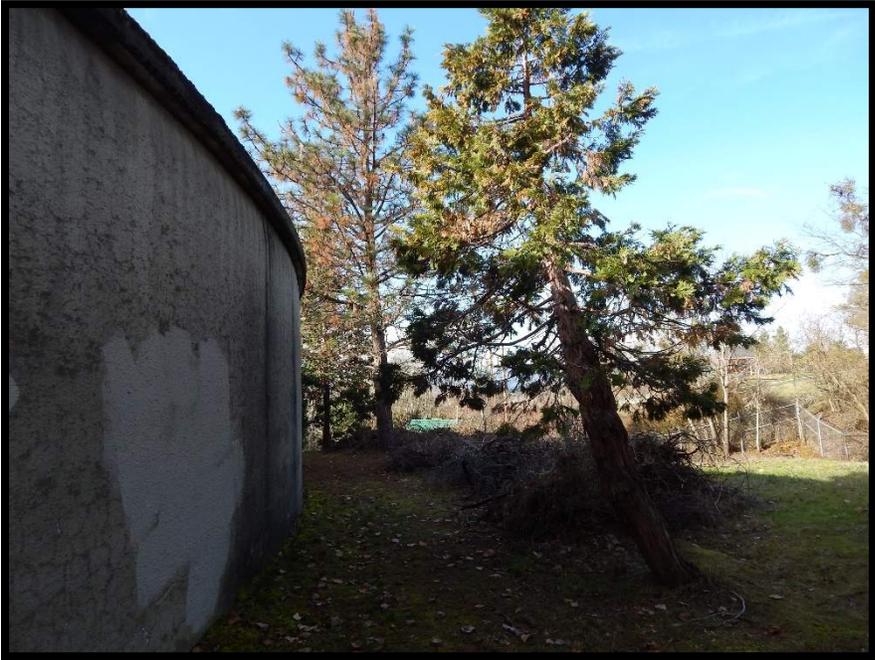
the perimeter of the Reservoir. A row of trees is present around approximately 120 degrees of the circumference on the North to Southwestern side that are located approximately 10-15' away from the Reservoir wall. The grade slopes generally from North towards the South and an irrigation drainage ditch/swale is located towards the South side of the Reservoir a distance away. There were no visual indications of any slope movement or impact of the adjacent ditch/swale. It is noted that the trees may eventually be a potential hazard to the roof edge and/or the root systems may eventually reach the tank wall and could cause damage to the areas below grade. In addition, the roof has deleterious organic debris from the adjacent trees in the form of pine needles, see Figure 2-11. This isn't a structural concern, but could increase the potential for stains down the side of the Reservoir.

Figure 2-5: Reservoir No. 5 – Adjacent Tree Line

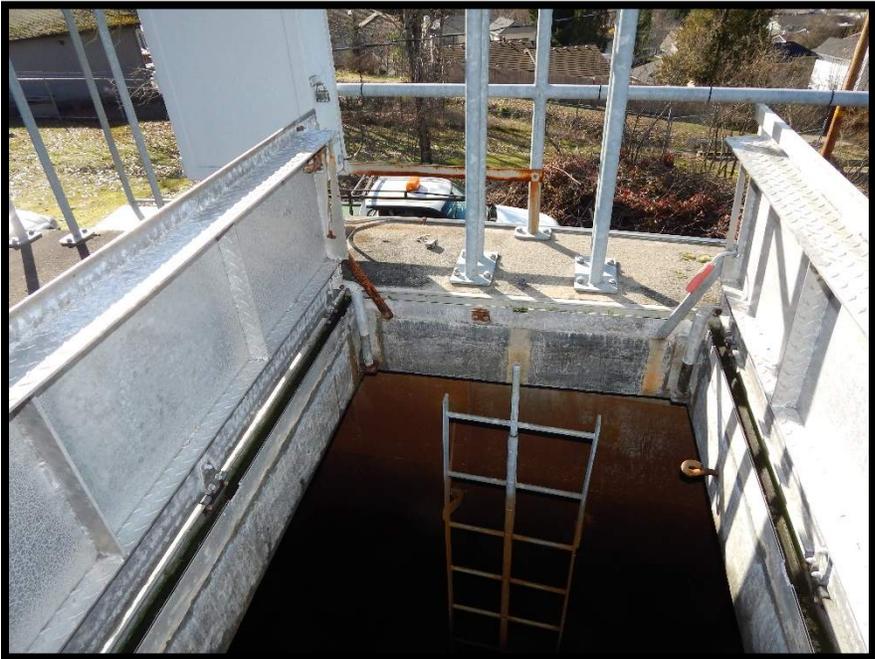
Figure 2-8: Reservoir No. 5 – Roof Hatch

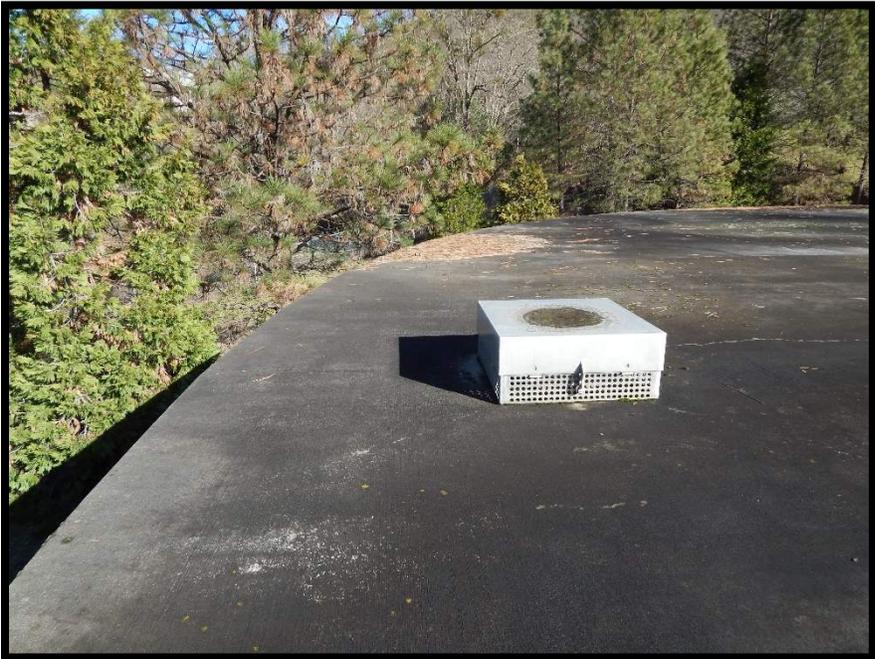
Figure 2-10: Reservoir No. 5 – Roof Hatch

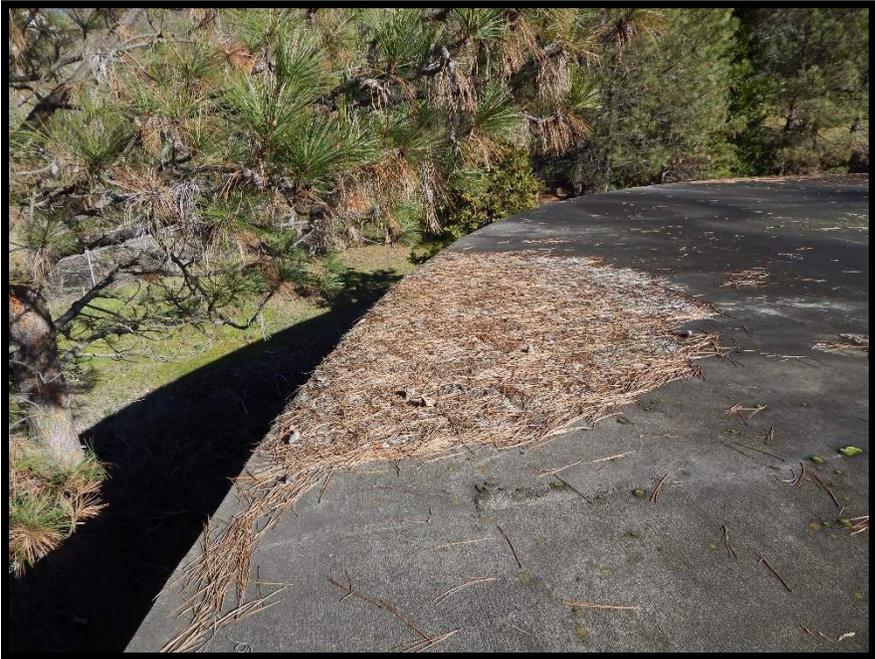
Figure 2-11: Reservoir No. 5 – Roof – Organic Debris

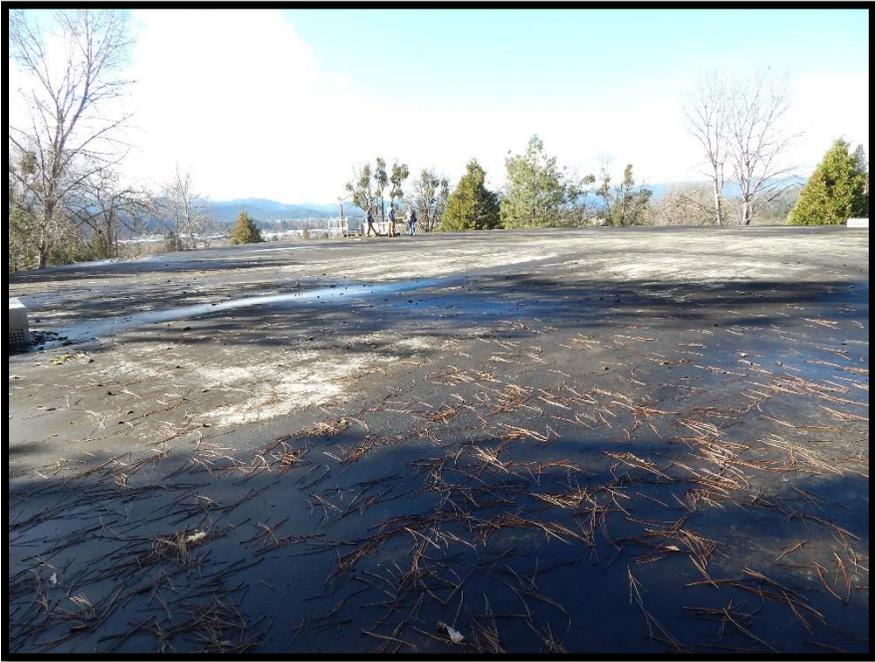
Figure 2-12: Reservoir No. 5 – Roof Ponding

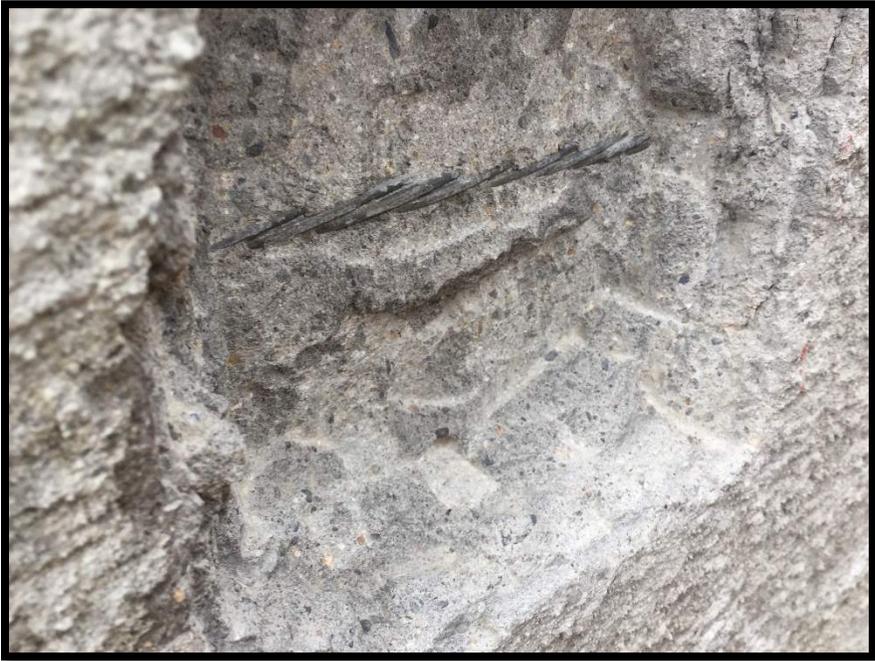
<p>General Date: February 13th Time: 8.00 am, Approximately Number of Locations: 3</p>
<p>Location No. 1 Site: Southeast, approximately 32" down from top of wall Strand: (1) exposed in 6" vertical expanse, no corrosion present Shotcrete: (2) 0.5" layers of delaminated, then 1" of competent before strand, appears competent past</p>
<p>Location No. 2 Site: Northeast, approximately 32" down from top of wall Strand: (1) exposed in 7" vertical expanse, no corrosion present Shotcrete: (2) 0.5" layers of delaminated, then 1" of competent before strand, appears competent past</p>
<p>Location No. 3 Site: Northwest, approximately 36" down from top of wall Strand: (1) exposed in 7" vertical expanse, no corrosion present Shotcrete: (2) 0.5" layers of delaminated, then 1" of competent before strand, appears competent past</p>

Figure 2-13: Reservoir No. 5 – Destructive Testing – Strand Wrapping

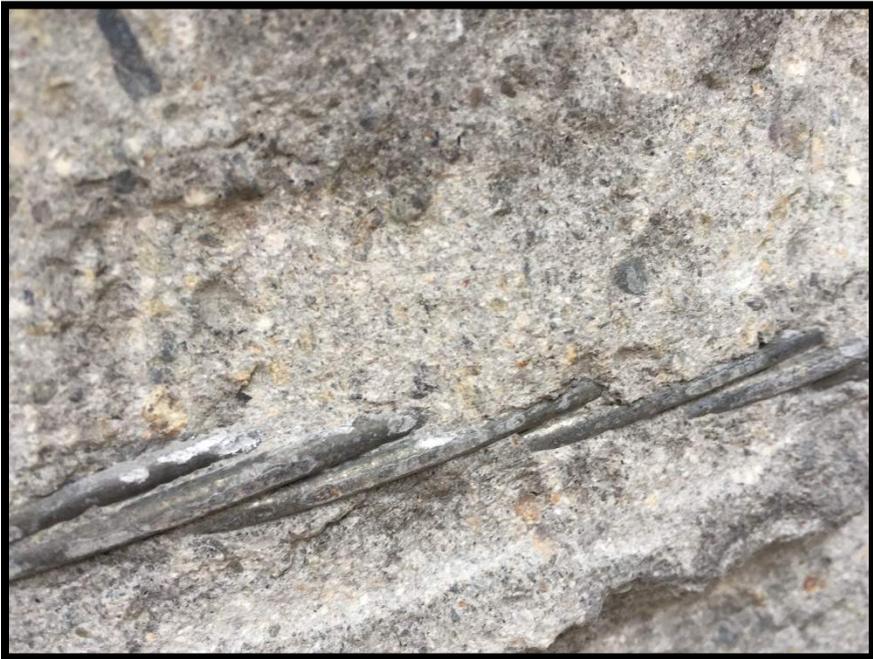
Figure 2-14: Reservoir No. 5 – Destructive Testing – Strand Wrapping

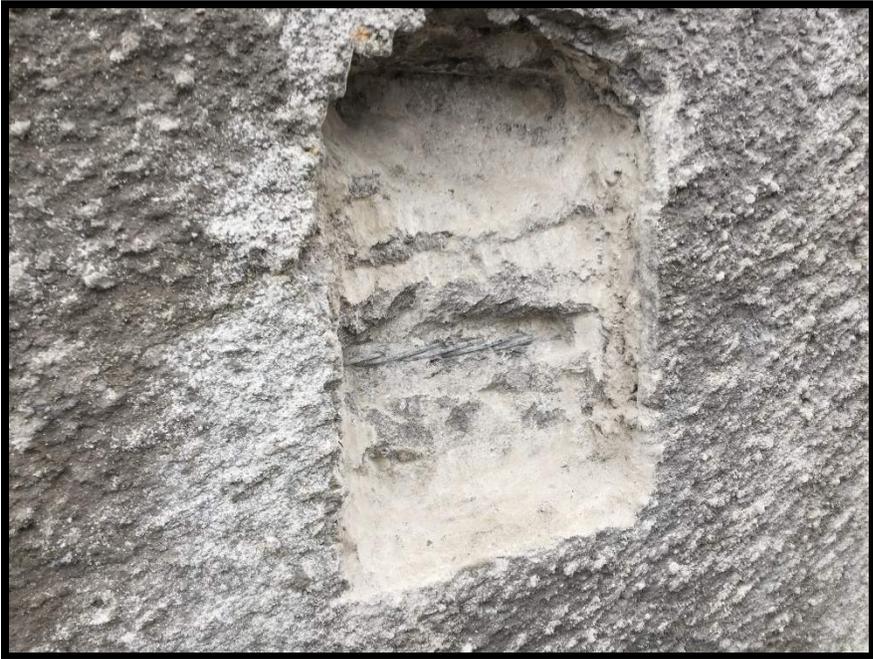
Figure 2-15: Reservoir No. 5 – Destructive Testing – Strand Wrapping

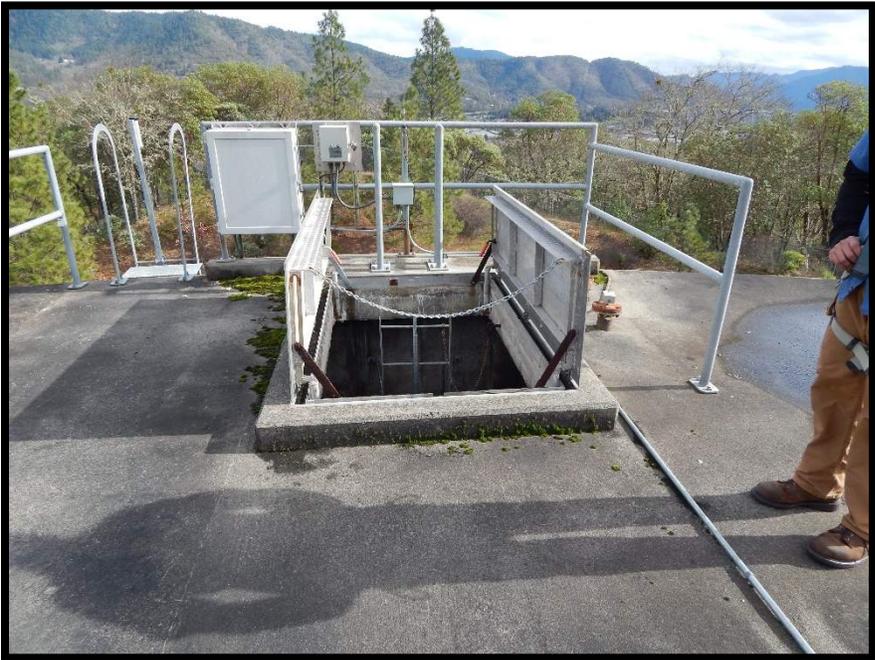
Figure 4-8: Hatch

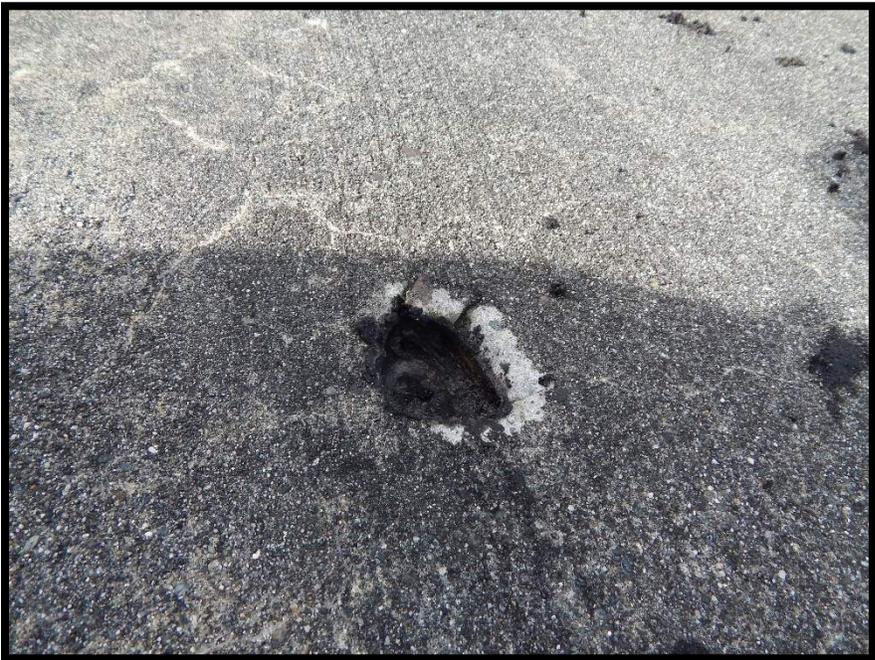
Figure 4-9: Large Rock Pocket (Dirt & Debris removed by hand)

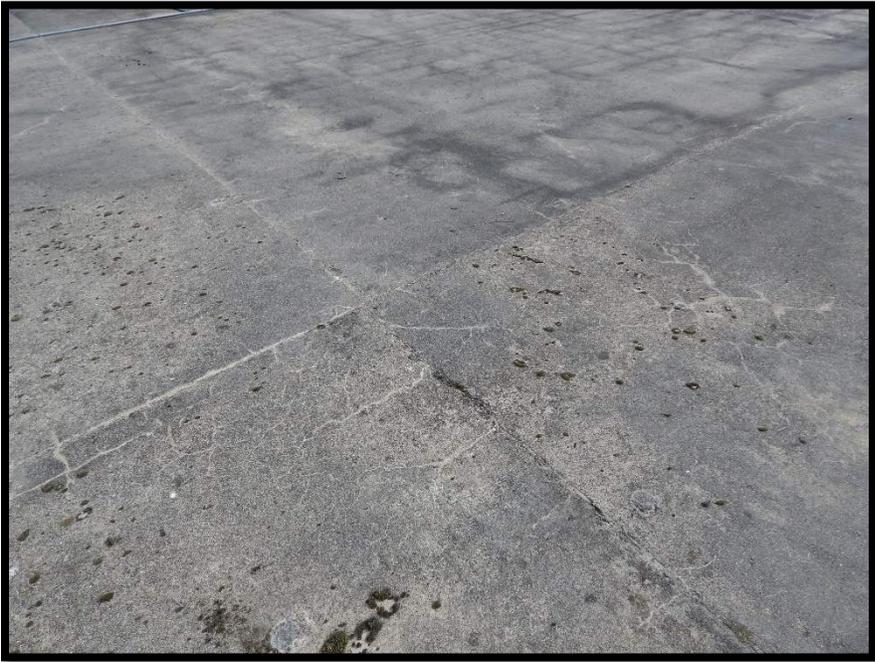
Figure 4-12: Roof Joint at Center

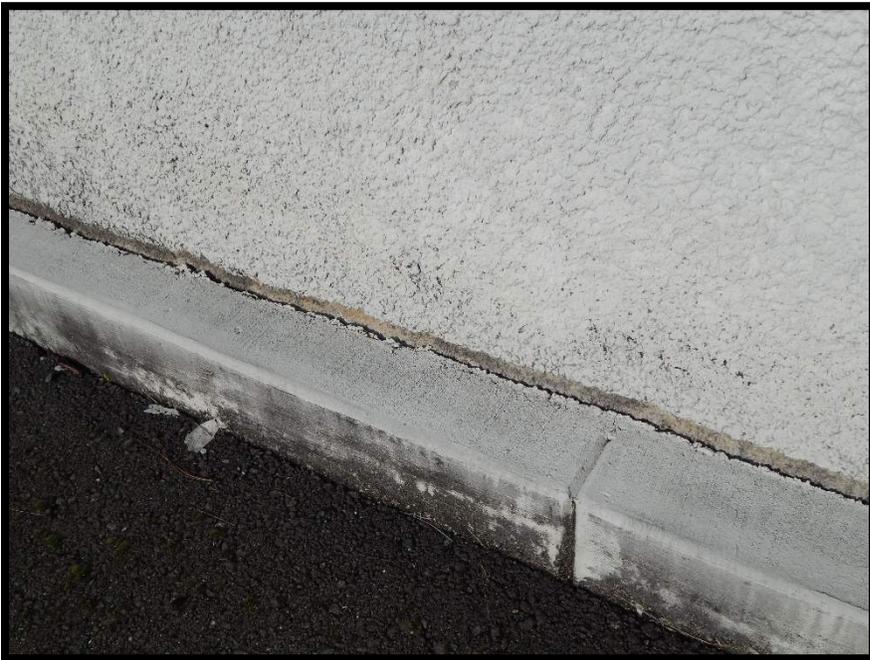
The finished grade around the perimeter of the Reservoir was paved for access around the full circumference. It was observed that there appears to have been roughly 0.75" of settlement of the subgrade around the Reservoir as evidenced by the curb.

Figure 5-8: Settlement at Curb

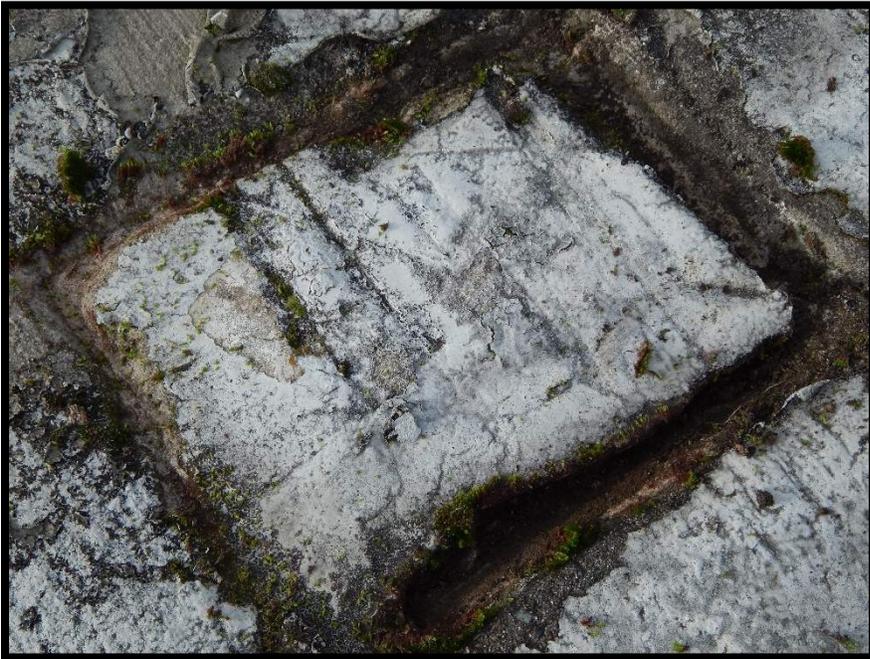
Figure 5-11: Shear Can at Vertical Tendons w/ Exposed Steel

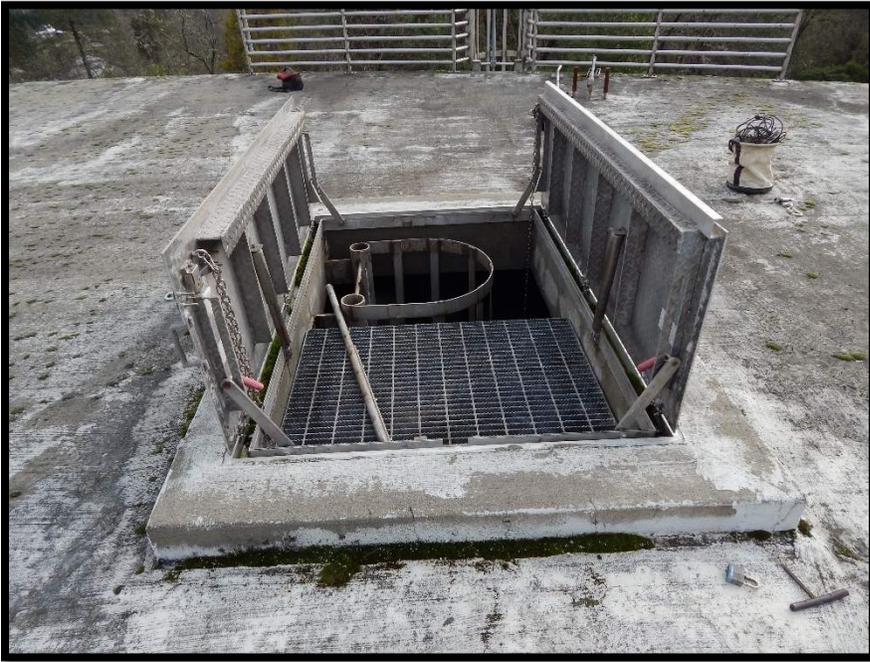
The roof hatch is 4'x6' and appears to be in good condition, however it appears to be an older style hatch which is no longer considered code compliant for water quality. The roof vent appears to be in good condition with no apparent structural deficiencies noted.

Figure 5-13: Hatch

From a water quality standpoint, the roof hatch does not meet current code requirements. We recommend that the City replace the hatch with a model that meets current Oregon DEQ water quality standards.

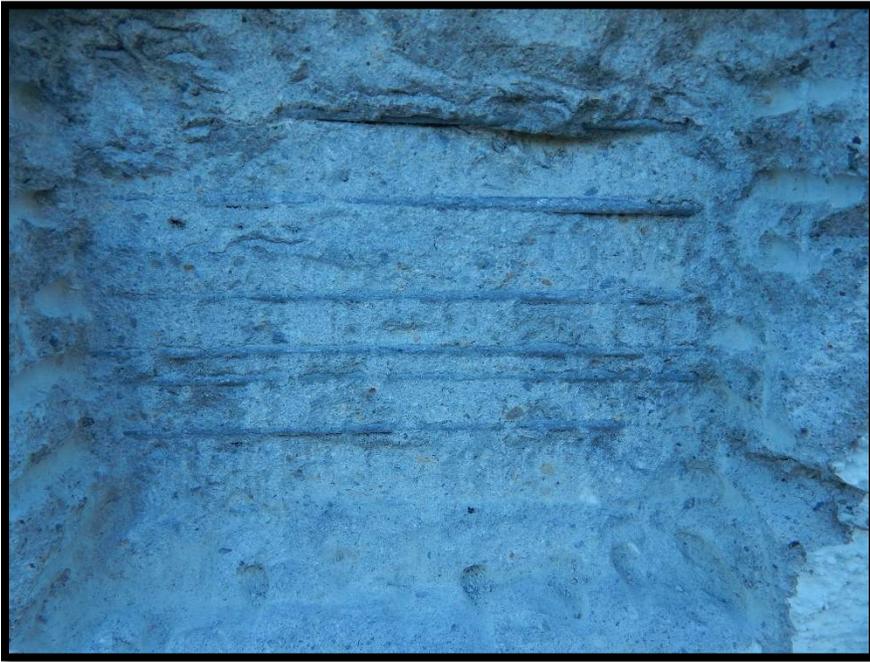
The observation of the wire showed no areas of corrosion where they are exposed. At these locations the wire appears to be in good condition. The locations chosen were based upon hammer soundings to locate areas with potential delamination/hollow spots that would be more likely to experience corrosion damage. The shotcrete in each of these locations was determined to be delaminated during the chipping process and in poor condition and was removed easier than competent shotcrete would be until the delaminated portion was removed. The delaminated area appears to be limited to the shotcrete layer covering the wire. The shotcrete behind the wires appears to be in good condition from the limited exploration. The depth of shotcrete was approximately 1.5"-1.75" to the inner (first) wrap of wire at all three locations. We were able to find the transition between inner (first) and outer (second) wrap layers as well and found that the depth of shotcrete between wraps was approximately 0.75" which is consistent with a 0.375" wire and 0.375" of shotcrete cover between wraps.

Figure 5-17: Exposed Wire Pre-stressing – Location 1

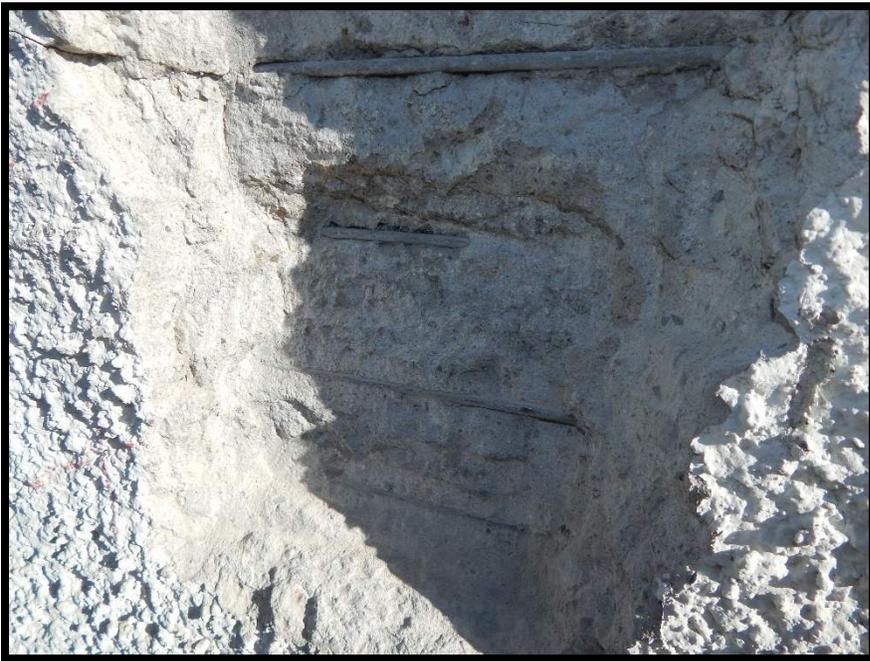
Figure 5-18: Exposed Wire Pre-stressing – Location 3

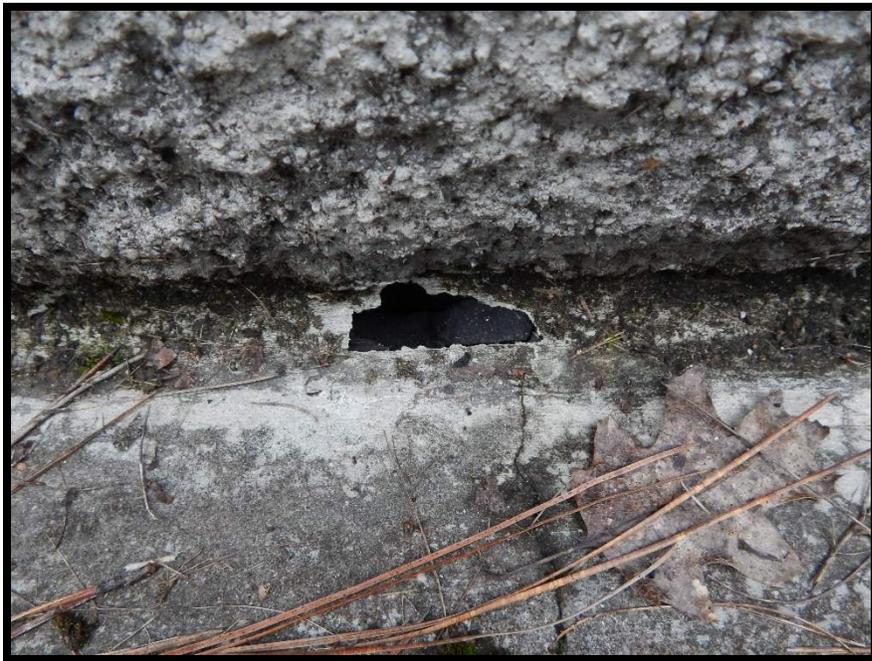
The exterior walls of the Reservoir are covered in shotcrete to protect the strand wrapping around the core wall. The Reservoir appears to be at or near grade with either the top of the footing exposed or a small slab poured around the perimeter. There is a sealant joint at the wall to top of slab joint that is failing in some locations. It is unclear what occurs below this joint as there is a void behind the sealant that extends downwards. We were unable to observe below the joint and there is no detailing in any of the original drawings that corresponds with the as-built observed condition (See Figure 6-12).

Figure 6-12: Close-up of Hole in Wall Base Sealant

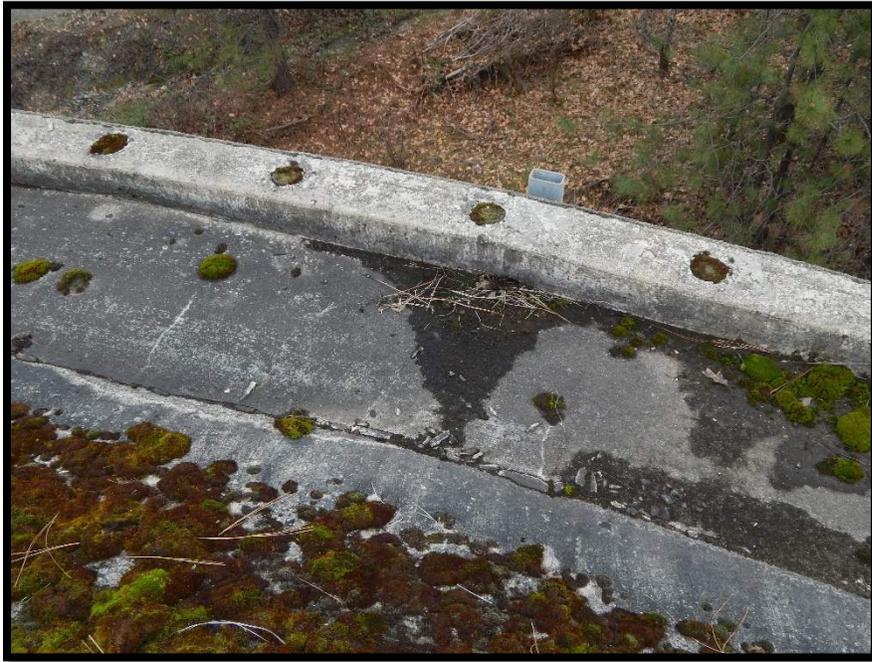
Figure 6-17: Drain Scupper (nearly clogged) & Top of Wall

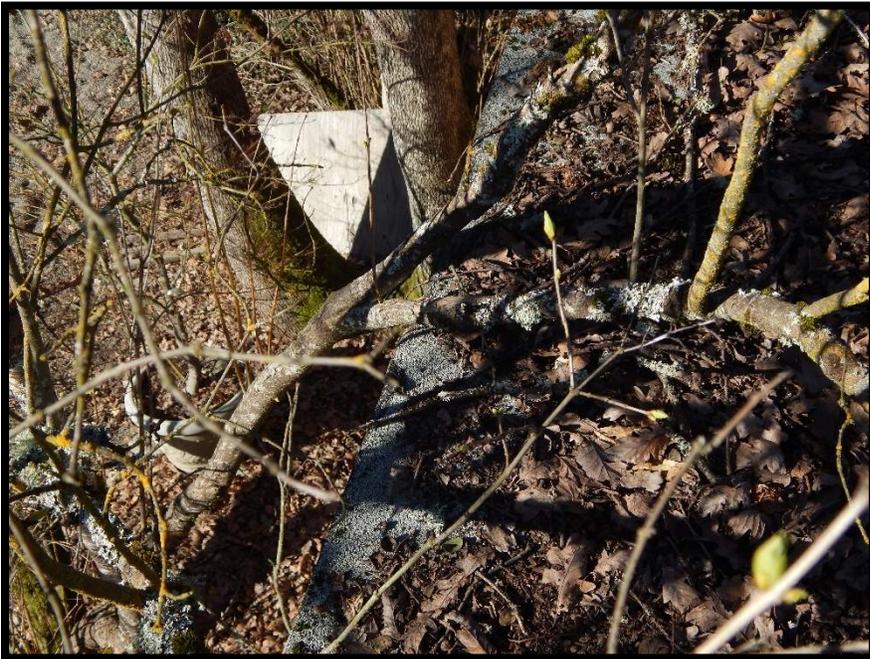
Figure 7-12: Tree growing against edge of Roof

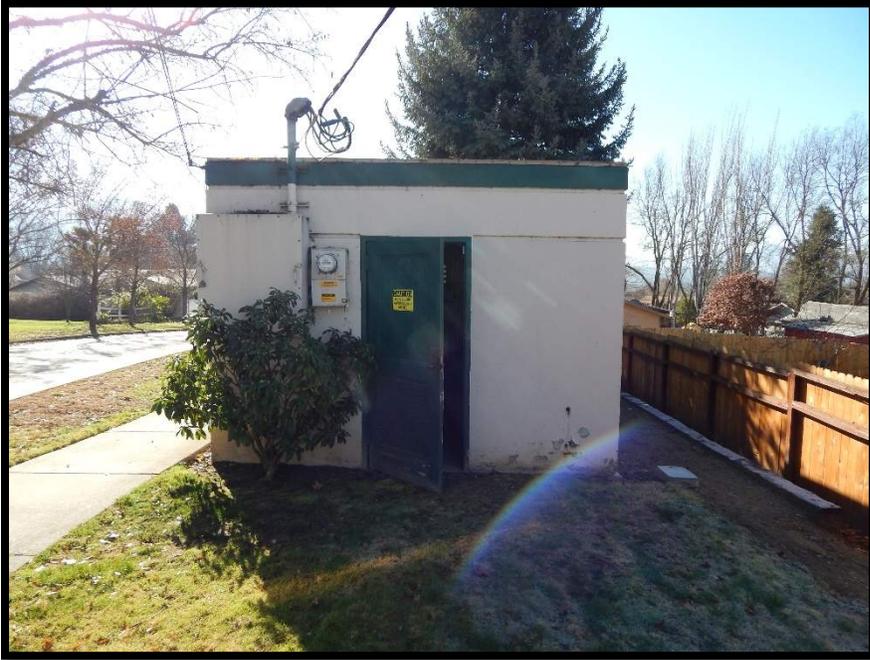
Figure 8-3: North Elevation

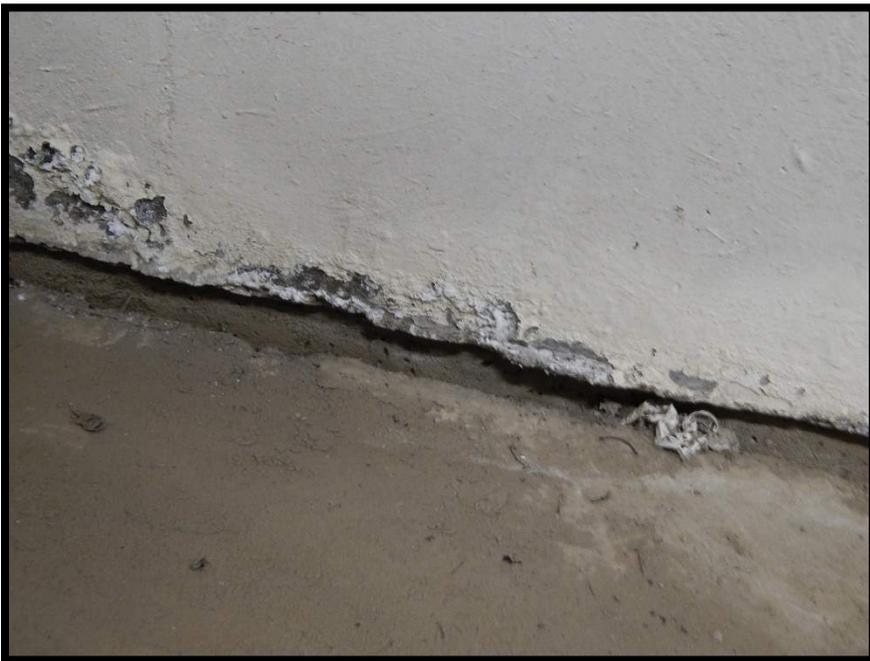
Figure 8-8: Differential Settlement at Wall/Floor Slab

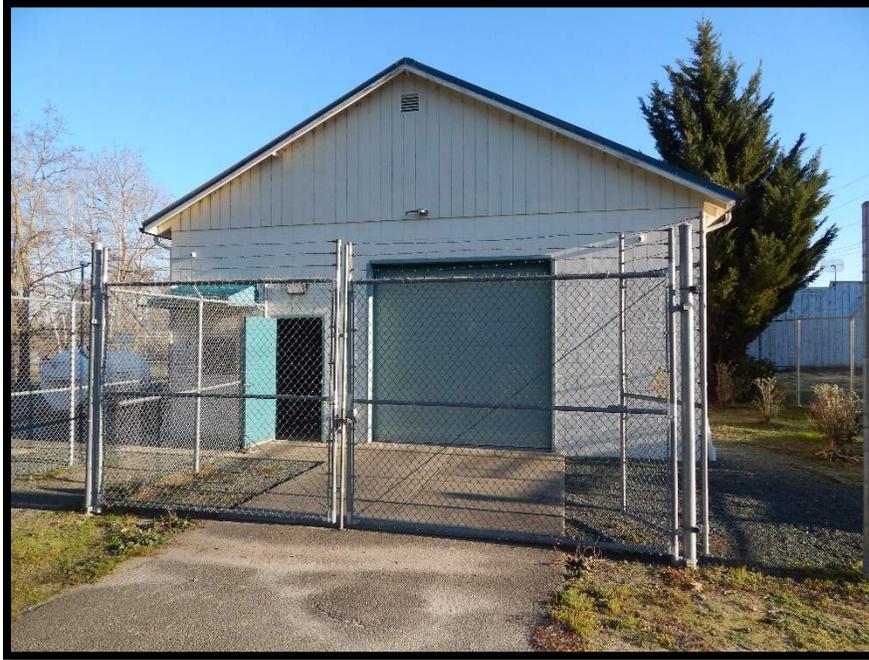
Figure 9-5: New Hope – South Elevation

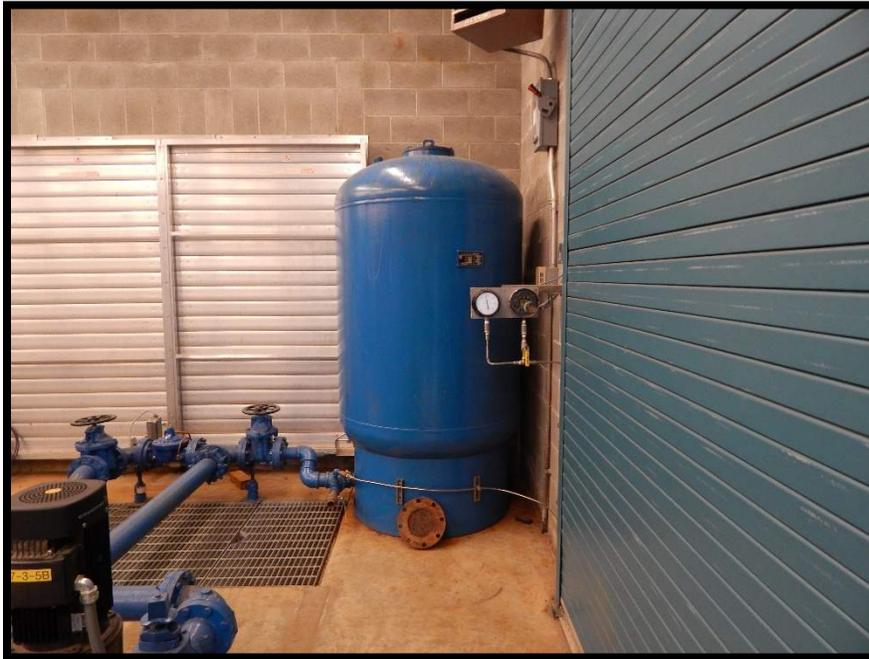
Equipment	Unable to determine if electrical equipment is anchored
General Observation	Pressure tank at Southern corner doesn't appear to be anchored

Figure 9-5: Unanchored pressure Tank
